Urgent Field Safety Notice Product Correction

Product Name	List Number	Serial Number	UDI
Alinity hq Analyzer	09P68-01	ALL	Not Applicable
Alinity hs Slide Maker Stainer Module	09P69-01	ALL

Abbott has identified the safety interlock covering the septum piercing probes may not deploy when the bulk solution 1 Liter bottle is removed on the Alinity h-series: Alinity hq Analyzer & the Alinity hs Slide Maker Stainer Module.

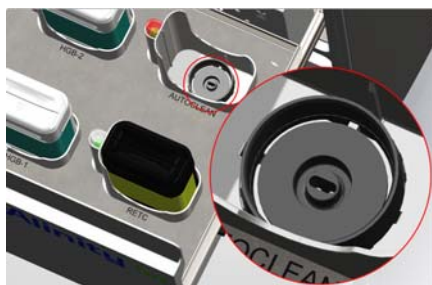
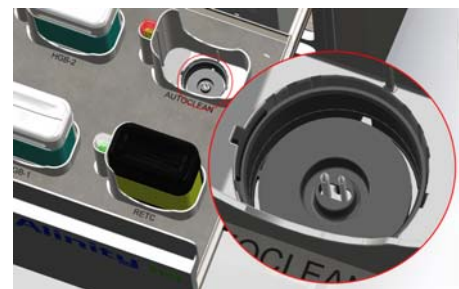
Drawings of Alinity hq Autoclean Solution bottle holder showing detail when the safety interlock covers the piercing probes and when the safety interlock does not deploy showing the exposed piercing probes. All bottle holders have identical piercing probes.

The septum piercing probes could cut or puncture the user's hand.

Please continue to follow the instructions provided in the Alinity h-series Operations Manual when replacing the bulk solutions. As indicated in the Operations Manual, use caution when accessing bulk solution bottle holders or replacing bulk solution bottles as you may be exposed to a sharp hazard.

If the safety interlock or bottle release does not function correctly, please contact your area customer support for assistance.

Your Abbott representative will be contacting you to schedule the placement of a new safety hazard labeling for CAUTION: Sharp Element in the bulk solution drawer to increase the user awareness of this hazard.
