Urgent Field Safety Notice Product Correction

Product Name	List Number	Serial Number	UDI
Alinity ci-series System Control Module (SCM)	03R70-01	All	N/A

Alinity ci-series issues resolved in software version 2.6.0

Alinity ci-series hardware issues resolved

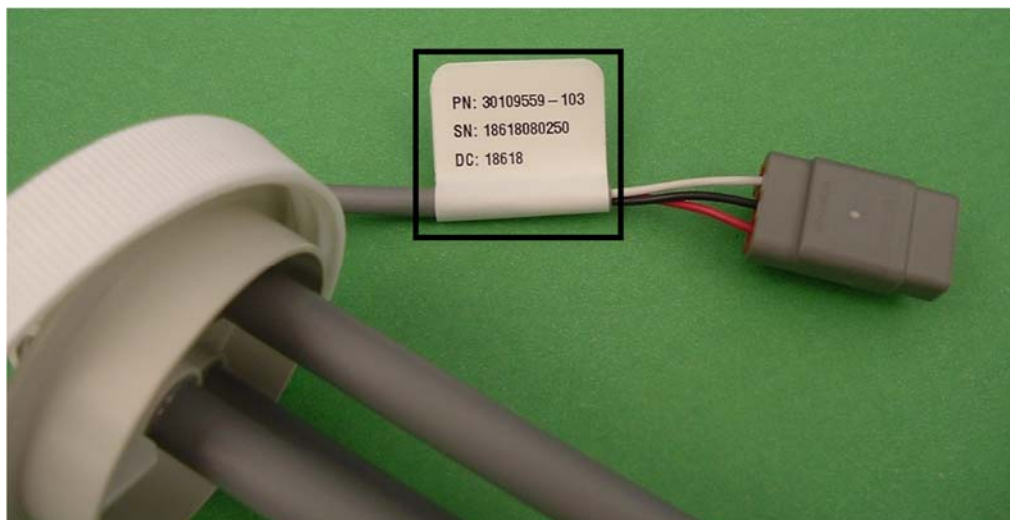
Figure 1. Level Sensor, Bulk Solution identification label

- If the part is in the box, the list number (04S68-01 or 04S68-02) is printed on the label
- If the part is removed from the box or installed on the Alinity ci series, the part number is printed on a label attached to the electrical connection for the part. See Figure 1 and Table 1 below.

List Number (LN)	Part Number (PN)	Instructions
04S68-01	30109559-102	Remove and replace any Level Sensor, Bulk Solution, LN 04S68-
04S68-02	30109559-103	01/PN 30109559-102 with LN 04S68-02/PN 30109559-103
