### Atellica® Solution

### Atellica CH 930 Analyzer – Three issues identified in Atellica Solution Software V 1.19.2 and below

### Reason for Urgent Field Safety Notice

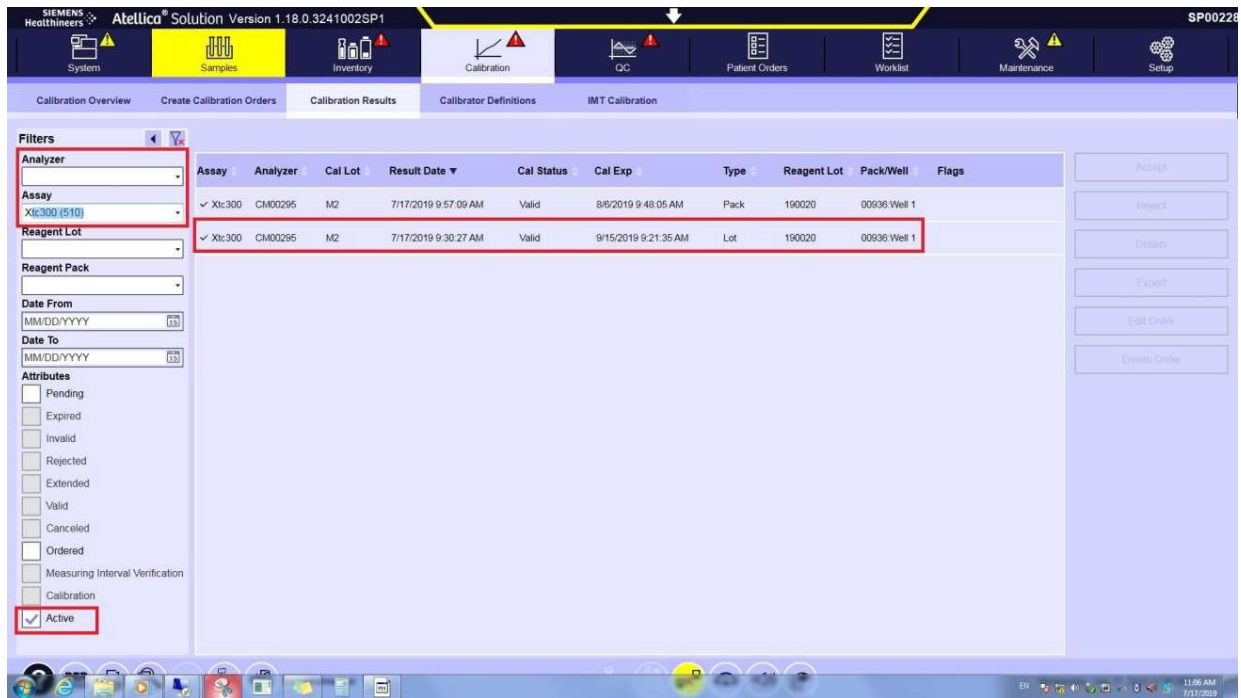
Figure 1. Calibration Results Screen

Assays	Issue observed
Issue #1: Ecstasy (SMN# 11097518)	The test definitions allow for 20 day pack calibration interval instead of 15 days. Based on Siemens Healthineers' investigation, there is no impact to the performance of the Ecstasy assay due to the extended pack calibration.
Issue #2: Total Protein (SMN# 11097604)	The test definition allows for a 185 day lot calibration interval instead of 181 days. Based on Siemens Healthineers' investigation, there is no impact to the performance of the Total Protein assay due to the extended lot calibration.
Issue #3: Rheumatoid Factor (SMN# 11097618)	The test definition allows for a 30 days Onboard Stability (OBS) interval instead of 21 days. Based on Siemens Healthineers' investigation, there is no impact to performance of the Rheumatoid Factor (RF) assay concentrations of approximately 7 IU/mL and 45 IU/mL due to the extended OBS. At a RF concentration of 75 IU/mL, a maximum decrease in recovery of 9% was observed due to the extended OBS.

3. Upon completion and acceptance of the lot calibration, record the date and time the calibration was performed by navigating to Calibration > Calibration Results and filtering on the appropriate assay and analyzer. (Reference Figure 1. Calibration Results Screen)

1. Navigate to Calibration > Calibration Results and select the TP Assay. (Reference Figure 1. Calibration Results Screen)
2. Record the date and time of the TP Lot calibration. A lot calibration will need to be performed 181 days from the recorded date.
