URGENT FIELD SAFETY NOTICE

Product	Part Number
UniCel DxH Slidemaker Stainer (DxH SMS)	775222
UniCel DxH Slidemaker Stainer II (DxH SMS II)*	C11477

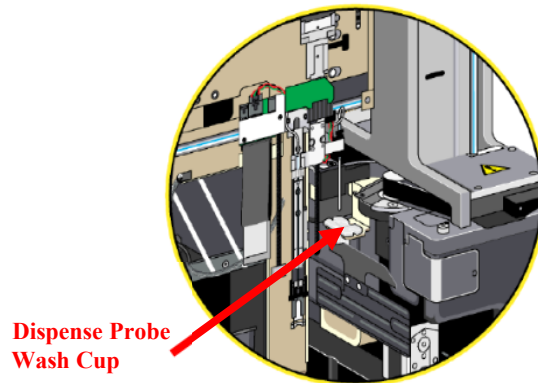
Figure 1 – Dispense Probe Wash Cup

Dispense Probe Wash Cup

1. Ensure the wearing of proper barrier protection according to your local and state laboratory safety regulations.
2. If the DxH SMS/DxH SMS II is connected to a Workcell, select the instrument from the System Status screen.
3. Select **Menu > Diagnostics > Dx Tools > Release SAM** from the local navigation bar > **Yes > Finish > Yes** at the prompt to continue.
4. Remove the Transport Shield and Lift the Front Cover. The instrument can trigger an audible alarm.
5. Select the **Turn Off Alarm** icon.
6. Ensure the SAM is moved all the way to the left side to avoid bending the dispense probe.
7. Locate the Dispense Probe Wash Cup (see Figure 1 below).
8. Locate the Dispense Probe Path (see Figure 2 below).
