## Urgent Field Safety Notice

**Commercial name of the affected product:** Aptio Automation

**FSCA-identifier:** FSCA – AP2 – 202303 – 03

**FSN-identifier:** FSN – AP2 – 202303 – 03 v.2

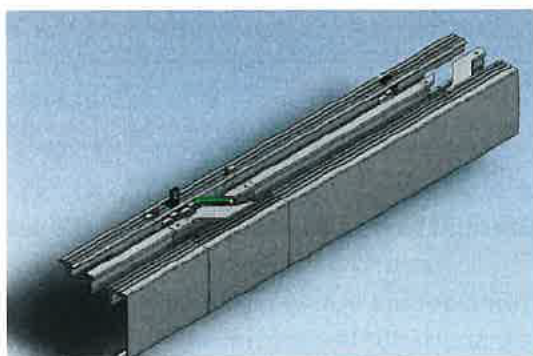
The scenario occurs in the case of a divert malfunction.

Image 1: Divert gate position

To avoid the occurrence of the described issue Inpeco recommends to visually check every day the gates at the buffer lane entry of the impacted modules (refer to Image 1) to verify that:

If the visual check is not passed, contact your local technical support for assistance before using the Automation System impacted modules to process samples.

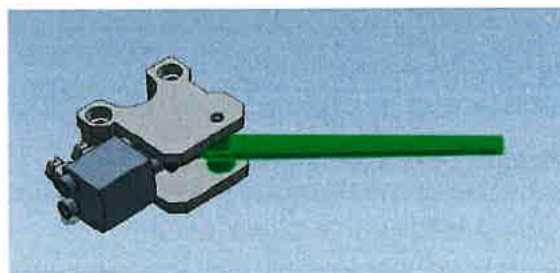
Image 2: Divert appearance

- there are no obstructions that prevent the correct activation and movement of the divert;
- the divert looks to be intact, refer to Image 2;
- the position of the divert is aligned to the profiles when it is diverting a tube, refer to Image 3; tubes that need to be routed by the module are diverted fluidly, without any missing or partial block of the carrier.

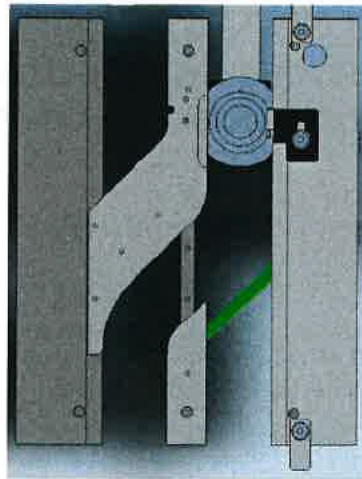
Image 3: Divert alignment
