## URGENT MEDICAL DEVICE CORRECTION

SUBJECT: P3700 Affinity® Three Birthing Beds distributed after October 2000 and equipped with the 12VAC Accessory Outlet option

# Subject: Affinity® Three Birthing Bed—Auxiliary Transformer Disabling Instructions

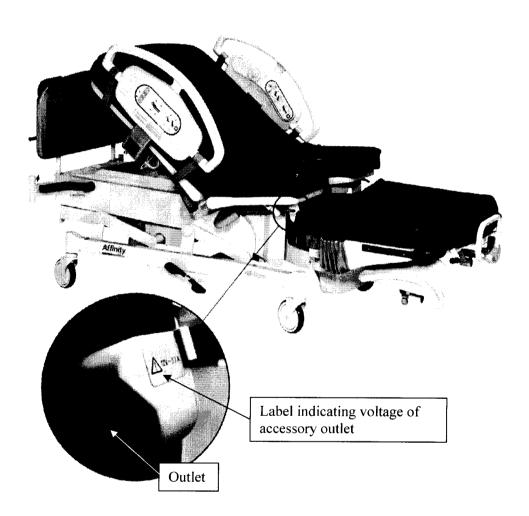
## **Location of Optional Outlet**

The affected units can easily be identified by viewing either the right or left side of the bed for the attachment of the optional 12VAC outlet. If your device has the outlet as indicated in the "Location of Optional Outlet," the Correction **must** be completed. If the outlets are not visible, then no transformer exists and no additional action is required for that bed.

In order to minimize disruption to your facility and to your patients, Hill-Rom is requesting that **this corrective action be implemented immediately** by your biomedical department. Instructions for disconnecting the transformer are enclosed. When this corrective action has been completed on all Affinity® Three Birthing Beds in your facility(ies), please complete the response card and return the card to Hill-Rom.
