**URGENT – Field Safety Notice
Philips IntelliVue Information Center (PIIC) iX**

SpO2 and/or Non Invasive Blood Pressure (NBP) alarms may become disabled without visual notification to the user

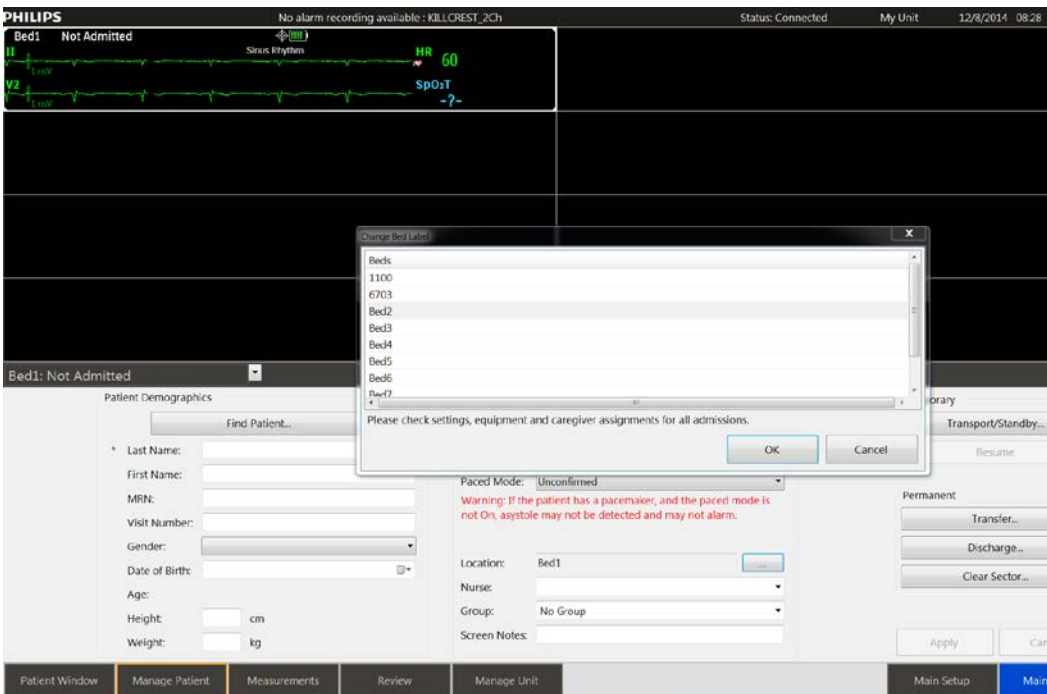
<p>AFFECTED PRODUCTS</p>	<p>The below part numbers for PIIC iX, (release A.00, A.01, and A.02) are impacted by this issue:</p> <p>866023 IntelliVue Info Center iX 866024 PIIC iX Upgrade 866117 PIIC Classic Upgrade</p>
<p>PROBLEM DESCRIPTION</p>	<p>A software defect has been identified that involves the use of the “Change Bed Label” feature at the Information Center iX. If the configuration for this item is set to “optional” and a user selects the “Location” button within the “Manage Patient” menu and makes a change to the patient location, alarms for SpO2 and/or Non Invasive Blood Pressure (NBP) will become disabled without visual notification (bell with an “X”) to the user. This problem only happens when the patient is monitored using a networked IntelliVue TRx Telemetry M4841/TRx4851A Patient Worn Device (PWD). Screen Shot showing Change Bed Label screen</p>

To prevent this issue from occurring, customers/users should:
 1) Disable the Change Bed Label field in Patient Management. This is accomplished by changing the feature from 'Optional' to 'Hidden' (see capture below)
 2) All patient transfers must be performed using the Transfer key in the Manage Patient application.

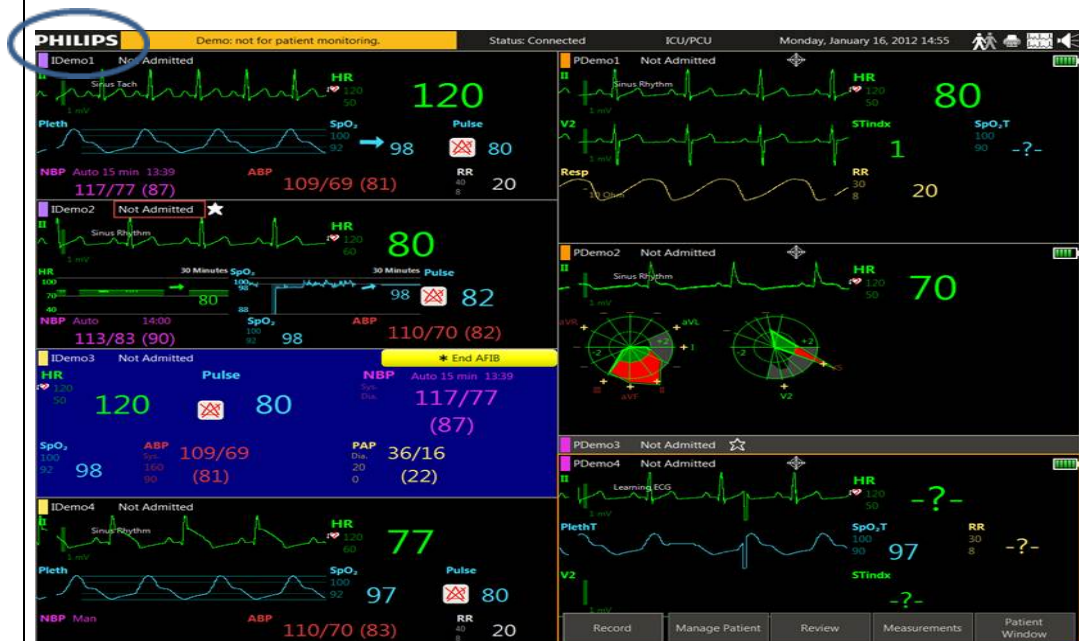
Figure 1 - Location of the Philips watermark

PIIC iX Revision A.XX – Identify the affected product by clicking on the Philips watermark on the PIIC iX surveillance display. See Figure 1. This will bring up the Product Support Page. Software Version has the release that the product is running. See Figure 2
