Urgent Field Safety Notice

GETINGE
GETINGE GROUP

Getinge is initiating a field safety correction with regards to Washer-Disinfector of GETINGE Getinge 46-Series (CM302) with PACS 300/350 control.

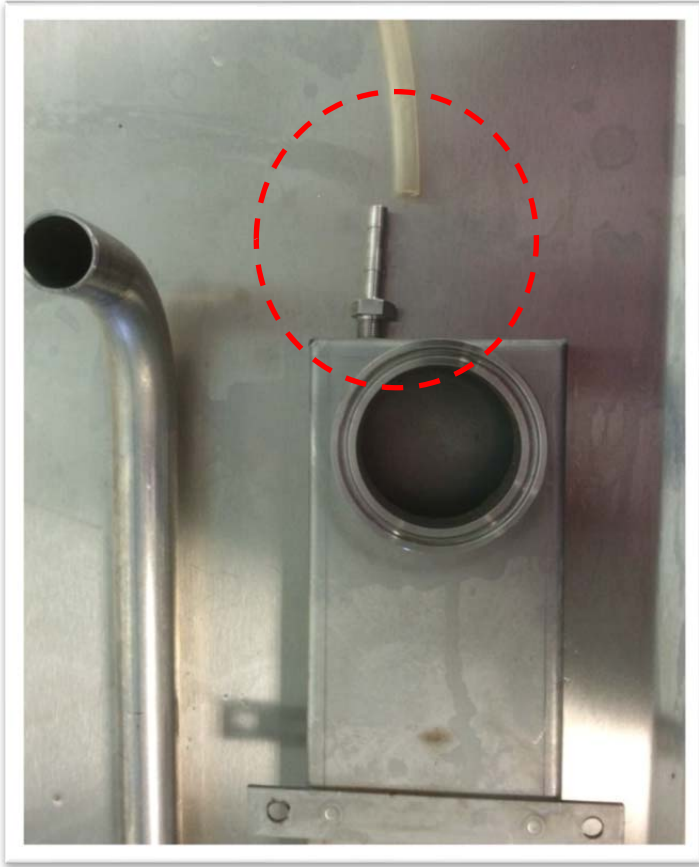
We have however now after performing detailed root cause analysis identified the problem as insufficient water flow throughout the manifold due to formation of air-pockets where sedimentation may occur. Use of detergents that are not recommended might also have negative impact.

Figure 1: vent hole added on top of manifold to prevent trapping of air.

- Cleaning of the manifolds.
- Adding ventilation-hole at the top of the manifold and linking it to the chamber i.e. preventing the formation of any air-pockets and secure a continuous water flow. See details in appendix 1
- Getinge will examine and exchange the check valve twice per year to ensure that there will be no sedimentation.
- In addition during the first 6 months after the corrective measures, monthly visual checks will be carried out by a Getinge service technician or a trained "user-facility" service technician who has received training/instructions from Getinge.
- Getinge will amend the instruction for use regarding the use of detergents, including a list of recommended detergents.

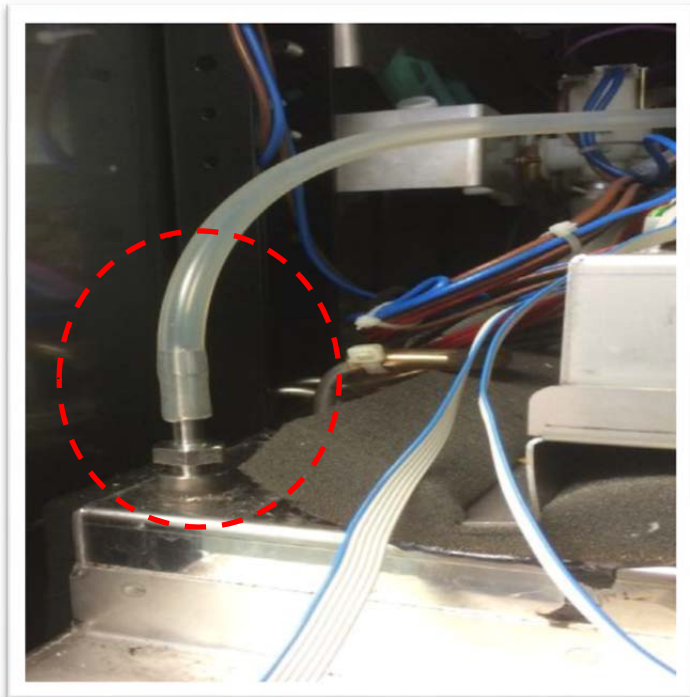
Figure 2: The vent hole is linked back to the chamber through a pipe
