## **URGENT – Field Safety Notice Philips M1783A and M5526A Sync Cables Electrical Interference Could Pose a Risk for Patients**

Philips has identified an issue when using M1783A and M5526A sync cables with some Philips monitor/defibrillators, which could pose a risk for patients. Further details on this issue are provided in the attached Field Safety Notice.

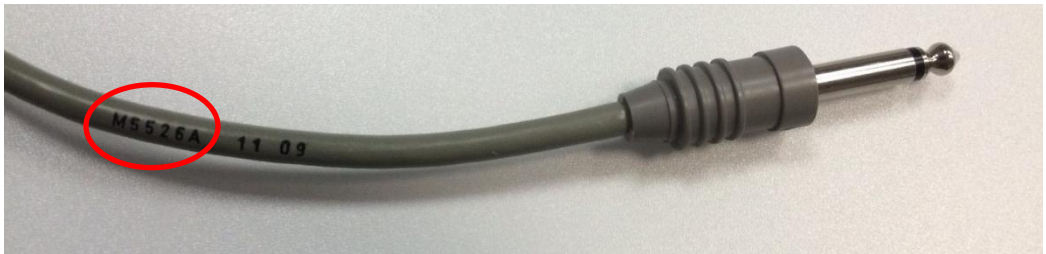
<p><b>HAZARD INVOLVED</b></p>	<p>When using a sync cable with the HeartStart MRx or HeartStart XL, EFT noise can be mistaken as an R-wave. If this occurs when performing synchronized cardioversion, there is a potential for inducing ventricular fibrillation if shocks are synchronized to EFT noise instead of the patient’s actual R-wave.</p> <p>When using a sync cable with the HeartStart XL+, EFT noise can disable ECG monitoring, and potentially interrupt demand mode pacing, leading to a possible delay in therapy. A power cycle is required to resume ECG monitoring. (Note: fixed mode pacing is not impacted by this issue.)</p>
<p><b>HOW TO IDENTIFY AFFECTED PRODUCTS</b></p>	<p>Philips M1783A and M5526A sync cables identified above are affected by this issue.</p> <p>The model number is printed on the outside of the cable, near the end with the ¼” phone plug, as shown below:</p>

<b>ACTION TO BE TAKEN BY CUSTOMER / USER</b>	<p>Prior to receiving a replacement sync cable, you can continue to use affected sync cables, provided that they are <b>only</b> used to connect the ECG Out jack on the monitor/defibrillator to the ECG (input) port on a bedside monitor. The issues described in this letter do not impact this application of the sync cable.</p> <p>Affected sync cables should not be used to connect the ECG Out jack of a bedside monitor to the ECG (input) port on the monitor/defibrillator.</p>
<b>ACTIONS PLANNED BY PHILIPS</b>	<p>Philips will replace all affected sync cables with a new sync cable free of charge. A Philips Healthcare representative will contact customers with affected devices to arrange for your replacement.</p>
<b>FURTHER INFORMATION AND SUPPORT</b>	<p>If you need any further information or support concerning this issue, please contact your local Philips representative: &lt;Philips representative contact details to be completed by the KM / country&gt;</p>
