Urgent Field Safety Notice

Type of action: Field Safety Corrective Action (FSCA, MEDDEV 2.12-1)

relating to multifunctional bed

XRCISE STRESS ECHO MED

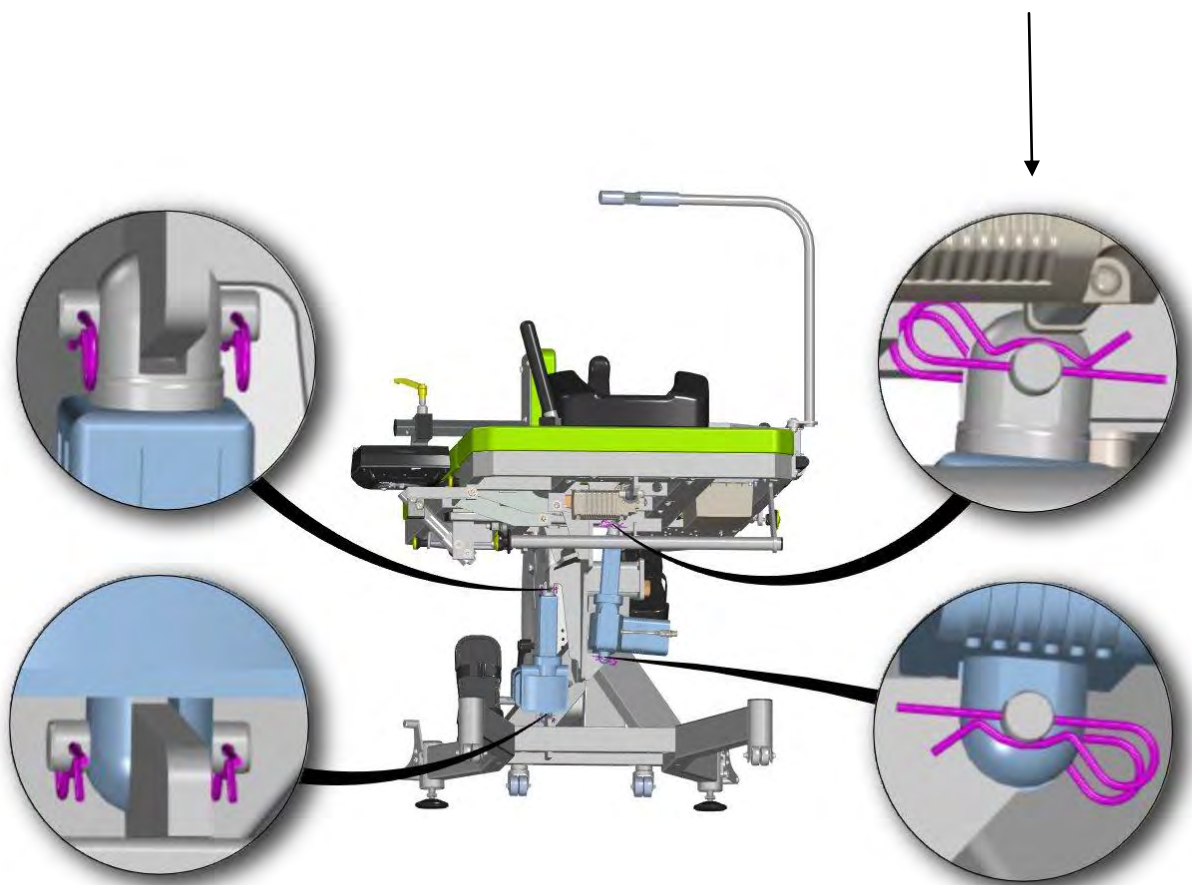
Illustration 1: Linear actuators secured with new spring cotter pins

The suspension respectively connection of the servomotor with the table top is fixed with a bolt. The bolts themselves are secured against axial shifting with a spring cotter pin.

On one multifunctional bed the spring cotter pin became loose. As a consequence, the bolt was disconnected from the mount as well, thereby the table top suddenly tilted back into the rest position.

During an in-house control we found out that some spring cotter pins may not have sufficient insertion force. Also, the rotating bolt may partly press the spring cotter pin out of the mount – another reason for insufficient insertion force.

The correct position of the spring cotter pins must be controlled before use (shown in illustration 1). If one spring cotter pin is missing or cannot be brought into the correct position, the XRCISE STRESS may not be used.

The spring cotter pins must be fixed and „locked“ in the shown positions.

For safety reasons, the bolts including the adapted pin must be replaced.

It is utmost necessary to control the support of the table tops.
