## Urgent Field Safety Notice

### Single Chamber Temporary External Pacemaker 53401

June 2018

Medtronic reference: FA824

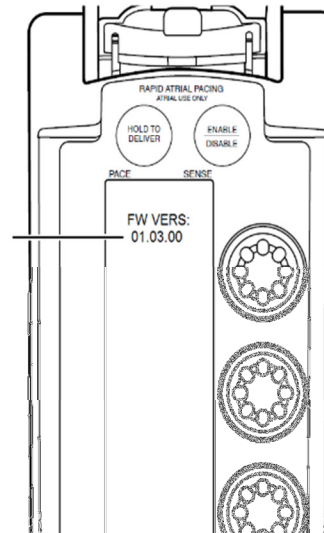
**FIGURE 1- updated firmware displayed in this image**

During power up process, Firmware Version will be displayed for 2 seconds

1. Verify whether 53401 EPGs in your possession are affected.
2. If your EPG is affected, complete the following:
  - Determine if the EPG firmware has been updated.
    - Power unit on and view firmware version (Figure 1 below).
    - If firmware version is 01.03.00 or greater, EPG firmware has been updated with correction for this issue. No other action is recommended.
    - If firmware version is 01.02.00, EPG firmware has not been updated. You may arrange to have your Medtronic Service Center update the EPG firmware at no charge.
