Customer Information Letter
Medical Device Correction
860306 Philips PageWriter TC30 Cardiograph
Blank I/O Module

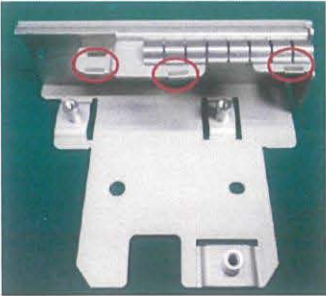
<p>AFFECTED PRODUCTS</p>	<p>The affected products are the 860306, Philips PageWriter TC30 cardiographs, with serial numbers: CN11731422 and CN11731453.</p>
<p>PROBLEM DESCRIPTION</p>	<p>A manufacturing assembly problem has been detected on the 860306 Philips TC30 Cardiograph, where three additional non-functional ground springs on the Blank I/O module could become loose potentially leading to an internal short that could cause the cardiograph to stop working.</p> <div style="display: flex; justify-content: space-around; align-items: center;"> <div style="text-align: center;"> <p>Incorrect Assembly</p>

ADVICE ON ACTIONS BY CUSTOMER / USER	Upon receipt of this notification, promptly locate your affected device.
ACTIONS PLANNED BY PHILIPS	Philips has issued a correction, free of charge. You will be contacted by a Philips representative to schedule an appointment to perform the removal of the additional non-functional ground springs from your Philips TC30 Cardiograph.
FURTHER INFORMATION AND SUPPORT	If you need any further information or support concerning this issue, please contact your local Philips representative: <Philips representative contact details to be completed by the KM / country>
