Urgent Field Safety Notice

Commercial name/Model: DA8K-10-14453 British standard power cord

FSCA-identifier: CP1905-JH00686

Type of action: Device exchange

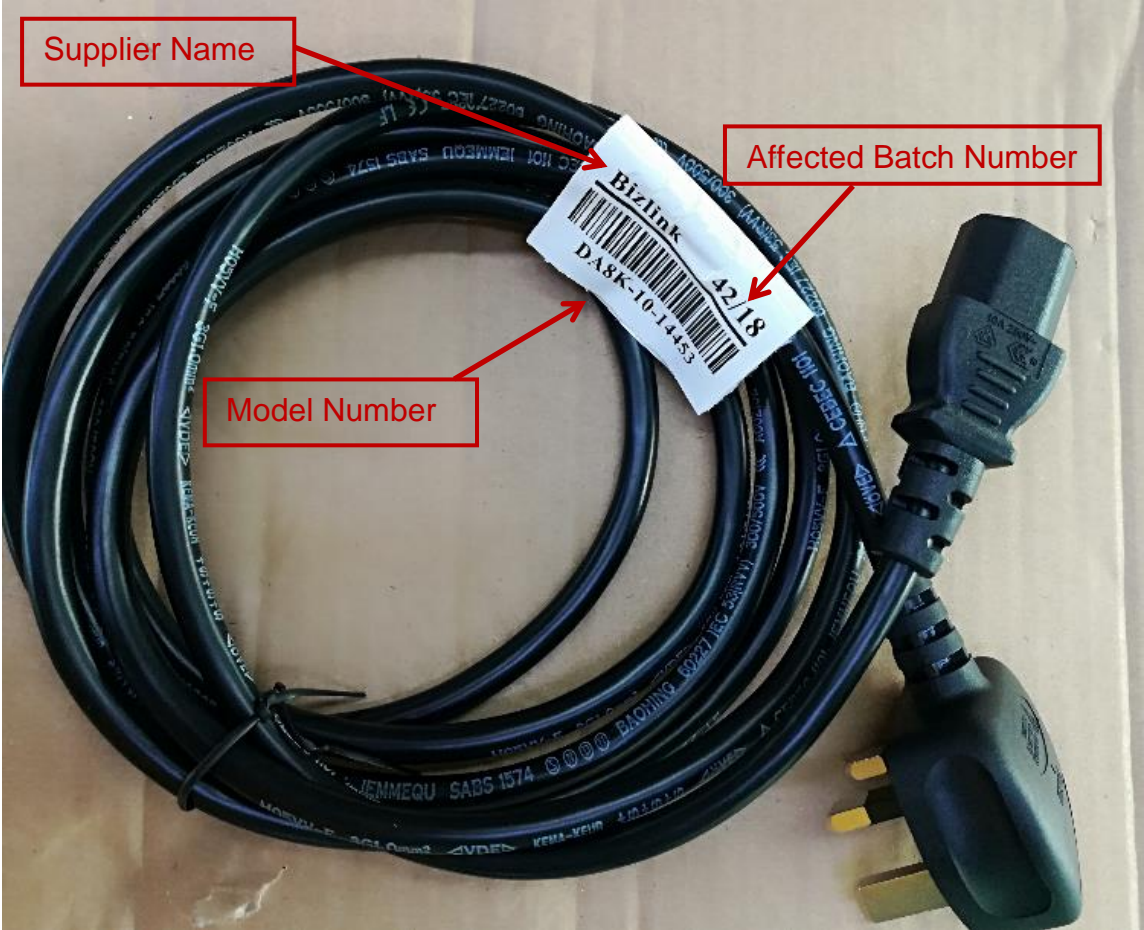
Figure 1 The information on the label

The affected batch No. of the British standard power cord is 42/18 which can be identified from the label. How to identify the batch number is listed in **appendix 1**

The label attached to the power cord contains the supplier name , model number and the batch number. Please refer to below pictures:
