Welch Allyn, Inc. 4341 State Street Road Skaneateles Falls, NY 13153 USA	URGENT: Field Safety Notice	MOD1329
---	------------------------------------	----------------

WelchAllyn GS777 Wall Transformer (all models) and PRO BP 3400 (handheld, desk mount, wall mount models)

Field Safety Notice

Subject: GS777 Wall Transformer and ProBP 3400 Potential Fluid Ingress (MOD1329)

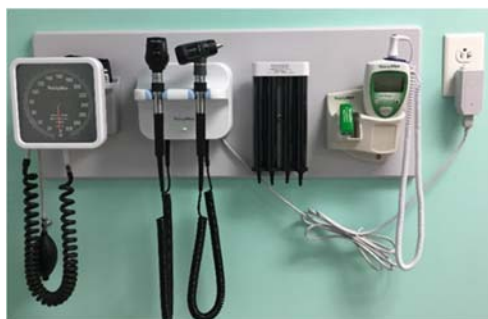
GS777 Wall Transformer

There is a risk of an internal electrical short and possible electrical shock occurring if cleaning fluid ingresses into the power supply, and the power supply is plugged into the electrical outlet before the cleaning fluid has completely dried. This notice is being distributed to make users aware of this potential risk and provide instructions for appropriately cleaning the power supply. The WelchAllyn GS777 is a device that is mounted either on the wall or on a mobile stand. It holds and supplies power to small handheld devices such as ophthalmoscope and otoscope heads. The ProBP 3400 Blood Pressure Device (all models) is a digital blood pressure device that can be used in a handheld, wall-mounted, or mobile configuration.

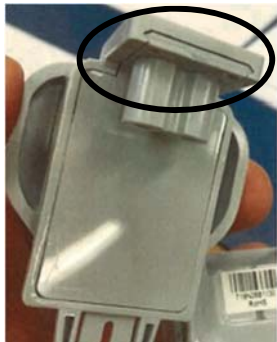
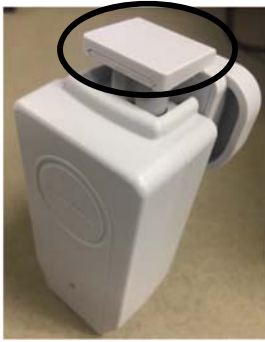
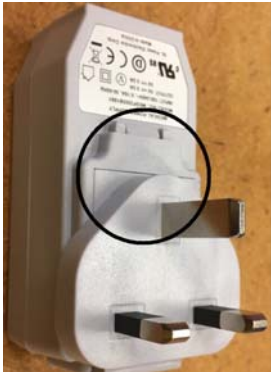
Our investigation has confirmed that the reported complaints were the result of unintentional fluid ingress into the power supply caused during cleaning.

Based on our investigation, unintentional fluid ingress is most likely to occur in the gaps of the adapter plug subassembly pictured below.

<i>Gaps in Adapter Plug Subassembly</i>	<i>Adapter Plug Subassembly Sliding into Power Supply</i>	<i>Gaps when adapter plug subassembly and power supply are fully assembled</i>

The GS777 and the ProBP 3400 power supplies are not intended to be cleaned with saturated wipes and should not be plugged into an electrical outlet when wet.

2. Ensure the cleaning cloth is not soaking (not dripping or over saturated) with cleaning fluid.
3. Apply minimal pressure on wipe when cleaning; avoid wiping gap areas identified on adapter plug as these areas are most susceptible to liquid ingress.
4. Ensure the power supply and power cord are dry before plugging into electrical outlet.
5. Hold the sides of the power supply when plugging into electrical outlet as pictured below. Avoid contact with bottom of the power supply where cleaning fluid is mostly likely to have accumulated.
