Welch Allyn, Inc. 4341 State Street Road Skaneateles Falls, NY 13153 USA	URGENT: Field Safety Notice	FA-2021-05-001-SKF-004
---	------------------------------------	------------------------

Braun® ThermoScan® Pro 6000 Ear Thermometer

Potential risk of probe tip overheating

FSCA-identifier: FA-2021-05-001-SKF-004

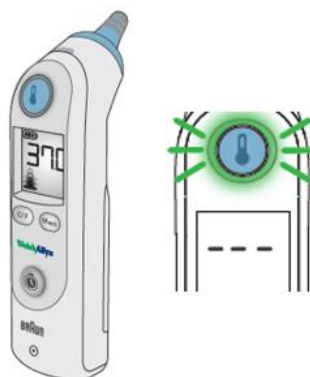
Figure 1

Our investigation has confirmed that the probe tip overheating is the result of fluid ingress. Fluid ingress causes the sensor to behave inconsistently, which does not allow the built-in safety mitigation (turn off the heating element) to work correctly. The majority of the devices which experience overheating of the probe tip show one of two behaviors at time of power up:

1. The ring around the measurement button will show a green blinking or flashing light instead of a ready state (solid green light).
2. The device requires multiple power-ups prior to going to ready state (solid green light). See Figure 1.

2. Do not use the device if the ring around the measurement button shows a green blinking or flashing light instead of a "ready state" (solid green light) and contact Hillrom Customer Service to report this issue.
3. Do not use the device if the device requires multiple power-ups prior to going to "ready state" (solid green light) and contact Hillrom Customer Service to report this issue.
4. If you experience an overheating probe tip, do not use the device and contact Hillrom Customer Service to report the issue.
5. Complete the attached response form and return to HillromSKF004OUS@stericycle.com within one month.
