Welch Allyn, Inc. 4341 State Street Road Skaneateles Falls, NY 13153 USA	URGENT: Field Safety Notice	2021-07-001-MKE-005
---	------------------------------------	---------------------

ELI280, MLBUR280 and BUR280 Electrocardiographs

ELI280 resting electrocardiograph - Patient mismatch/Software Upgrade

FSCA-identifier: 2021-07-001-MKE-005

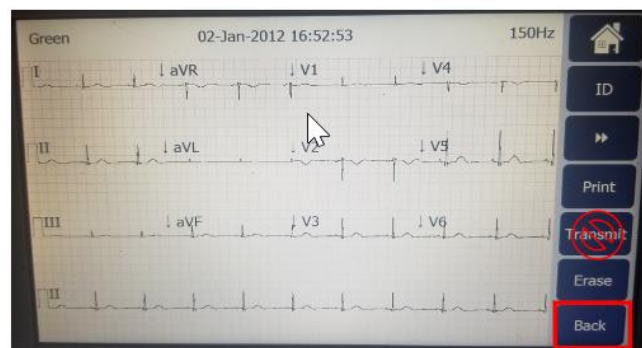
Figure.1

1. An ECG is acquired for Patient A and stored to the cardiograph.
2. An ECG is acquired for Patient B and stored to the cardiograph.
3. The ECG record associated with Patient A is retrieved from memory and any Patient Demographic information is edited.
4. After editing, the "Resting ECG" screen is presented as shown below. Figure 1
5. Pressing the TRANSMIT button from this screen (following any Patient Demographic edit) will transmit an ECG record other than for patient A. (see figure 2, which shows the Resting ECG screen).

If an ECG record is retrieved from the patient directory for a Patient Demographic edit to be performed, once the information has been edited and the screen above (Fig 1) is presented, do not press the transmit button. Instead, press the BACK button which will SAVE the changes to memory and present the user with the following screen, where the SYNC button can be used to transmit the desired record to the configured destination.

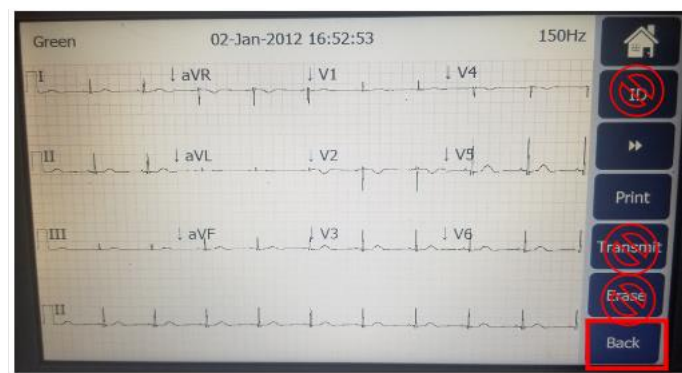
Figure.3

1. An ECG is acquired for Patient A and stored to the cardiograph.
2. An ECG is acquired for Patient B and stored to the cardiograph.
3. The ECG record associated with Patient A is retrieved from memory and ID information is edited.
4. After editing, the “Resting ECG” screen is presented as shown in Figure 3.
5. The user decides to make another ID Edit without leaving the “Resting ECG” screen and presses the “ID” button - Figure 3.

6. After the second edit is performed, the “Resting ECG” screen is once again presented as shown above.
7. Pressing the TRANSMIT button from this screen (following two ID edits in a row as defined above) will transmit an ECG record with the patient demographics

from Patient A and the ECG record for Patient B, this “hybrid” record is then stored in the cardiograph as second record with patient A demographics, and Patient B will no longer be listed in the directory.
