Voluntary Field Safety Notice (FSN)

Metrax GmbH has determined that in very rare cases, upon activating the device, the following M250 HeartSave devices may suffer from a malfunction in the form of a complete loss of function. Upon activation, the devices may fail without warning and may no longer be operable.

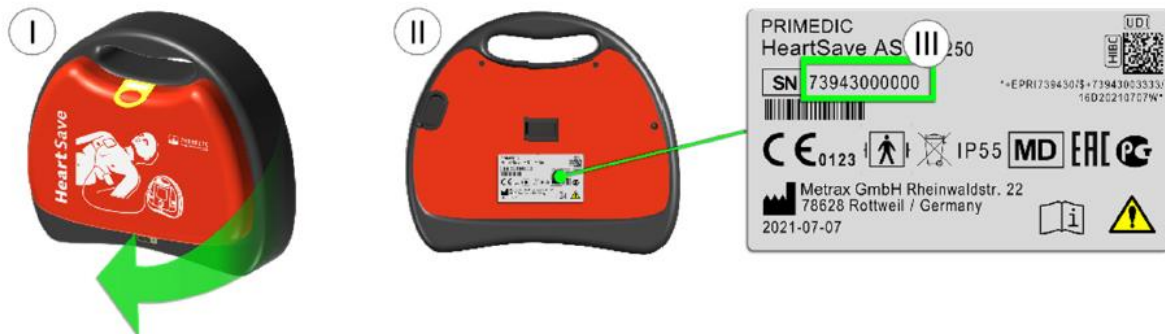
Figure 1 example: Type plate of a PRIMEDIC HeartSave AS (figure similar)

You can find the serial number and name of the affected devices on the silver type plate on the rear of the device, as shown in the figure.
