Customer information on:

Wallaby III Femoral Revision Component
REF # 43.26.40-01, LOT #: 2301210

Wallaby III Femoral Revision Component
REF # 43.26.43-02, LOT #: 2260220

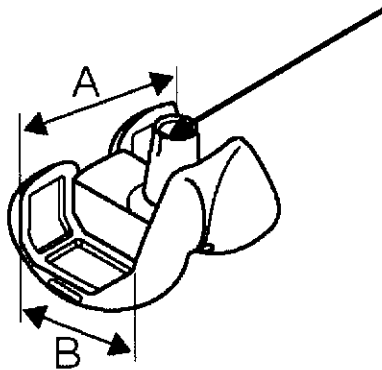
Zimmer has recalled these two lots of Wallaby III Revision Femoral components due to missing laser marking. The missing laser marking is used for orientation of the stem when an angled stem is implanted.

The marking on the turret of the Wallaby III femoral component – see drawing above – serves to position a 2° angled stem extension. By using a 2° angled stem extension a valgus angle of 3° or 7° can be obtained (versus a 5° standard valgus angle when using a straight stem extension). The marking is only relevant when using an angled stem extension. It does not have any function when using a straight stem extension. The use of angled stem extensions is relatively uncommon. For Wallaby stem extensions sold in 2006, 84% were straight stems and 16% were angled stems.

Should you have concerns with implanted devices, we recommend that the original patient chart be reviewed to determine if an angled stem was used (1 in 6). If an angled stem was used, we recommend review of postoperative radiographs to confirm the intended valgus angle. In a surgery where the incorrect valgus angle occurred undetected, this could affect the knee kinematics and long stem stability of the knee implant. However, we reiterate that there is a very low probability that this would have been undetected during the surgical procedure.
