Urgent Field Safety Notice

Product name: seleXys TH+ and seleXys TPS shells
FSCA ID no.: FSCA 15/02
Type of action: **Field Safety Notification due to higher than expected revision rate**

Bettlach, 15 September 2015

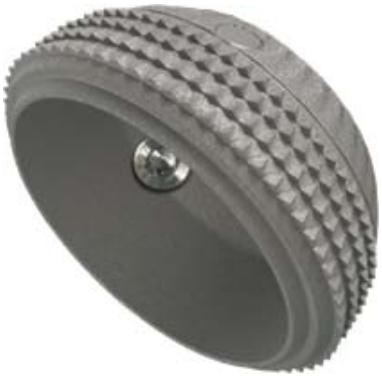
seleXys TH+ shell	Item number	Item description	Batch numbers
	55.42.0142	seleXys TH+ shell 42/AA	all
	55.42.0144	seleXys TH+ shell 44/BB	all
	55.42.0146	seleXys TH+ shell 46/CC	all
	55.42.0148	seleXys TH+ shell 48/DD	all
	55.42.0150	seleXys TH+ shell 50/EE	all
	55.42.0152	seleXys TH+ shell 52/FF	all
	55.42.0154	seleXys TH+ shell 54/GG	all
	55.42.0156	seleXys TH+ shell 56/HH	all
	55.42.0158	seleXys TH+ shell 58/II	all
	55.42.0160	seleXys TH+ shell 60/JJ	all
	55.42.0162	seleXys TH+ shell 62/KK	all
55.42.0164	seleXys TH+ shell 64/KK	all

A recent analysis of data derived from the Australian Orthopaedic Association National Joint Replacement Registry (AOANJRR) shows that the revision rates for the seleXys TH+ and seleXys TPS acetabular shells are higher than the revision rate of other acetabular cups/shells being used in Australia. The AOANJRR identifies loosening/lysis as the most significant reasons for revisions of the seleXys TH+ and TPS shells.

This Field Safety Notice does not change current practices for patient follow-up care for the seleXys TH+ and seleXys TPS systems. Mathys Ltd Bettlach is recommending that physicians maintain their routine follow-up protocol for patients who have undergone hip arthroplasty.

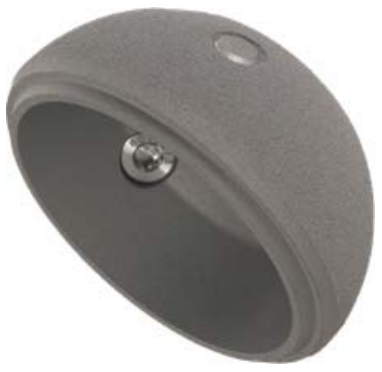
seleXys TPS shell	Item number	Item description	Batch numbers
	55.40.0042	seleXys TPS shell 42/AA	all
	55.40.0044	seleXys TPS shell 44/BB	all
	55.40.0046	seleXys TPS shell 46/CC	all
	55.40.0048	seleXys TPS shell 48/DD	all
	55.40.0050	seleXys TPS shell 50/EE	all
	55.40.0052	seleXys TPS shell 52/FF	all
	55.40.0054	seleXys TPS shell 54/GG	all
	55.40.0056	seleXys TPS shell 56/HH	all
	55.40.0058	seleXys TPS shell 58/II	all
	55.40.0060	seleXys TPS shell 60/JJ	all
	55.40.0062	seleXys TPS shell 62/KK	all
55.40.0064	seleXys TPS shell 64/KK	all
