Urgent Field Safety Notice **Endurant™ II/IIIs Stent Graft System** Radiopaque (RO) Marker Bond Detachment Recall

June 2021

Medtronic reference: FA982

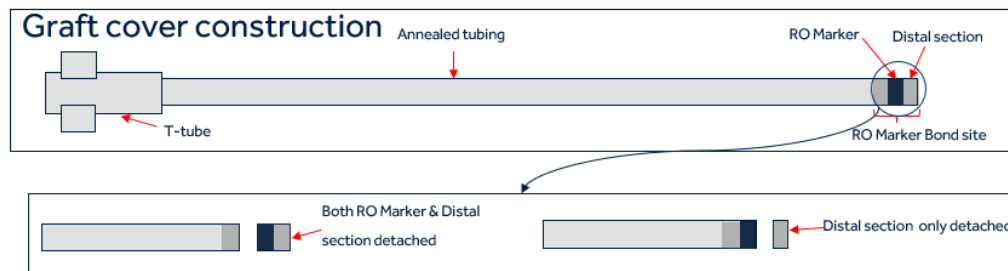
Figure 1: Shows a schematic of the Delivery System Graft Cover construction and RO Marker Bond detachments observed

The potential hazardous situation related to the RO marker bond detachment would occur during stent graft deployment. As the stent graft is being deployed, the RO marker bond may detach and constrain the suprarenal stent, leading to partial deployment of the stent graft and the inability to remove the delivery system. Conversion to open repair may be required to remove the delivery system and partially deployed stent graft from the patient. To mitigate patient safety risk, Medtronic is taking action to retrieve this specific subset of unused devices.

- Return all unused affected devices to Medtronic. Your local Medtronic Representative can assist you in the return and replacement of this product as necessary.
- Please forward this notice to all those who need to be aware within your organization.
