Date
February 2005

To all customers and users using AIR dual plug connectors as additional taps for medical compressed air

Important safety notice! **Exchange of AIR dual plug connectors, part number G01166**

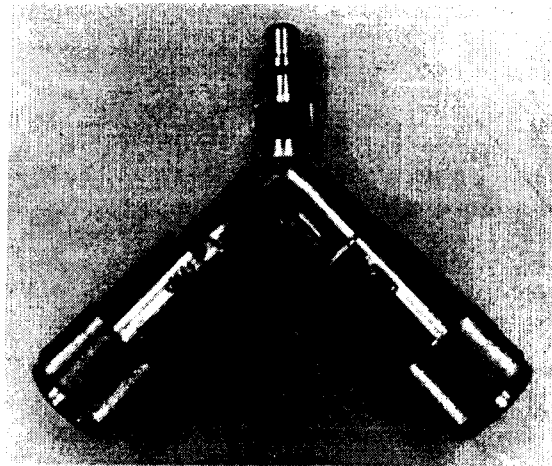
In the course of our product testing we have discovered that AIR dual plug connectors manufactured up to the year 2000 allow the possibility of connecting to a vacuum hose, resulting in a short-time pressure surge.

AIR dual plug connector, to be replaced

The identified cause of the fault was a dimensional non-conformance inside the AIR socket. We are not aware of any confusion occurring in day-to-day clinical practice.

When the vacuum regulator is plugged into the AIR connector it does not lock in, but there is a brief pressure surge in the connected scavenging system. The fault is directly detectable by a loud whistling. In the Dräger cylinder packs for bronchial suction and continuous drainage the pressure is immediately relieved again, as the cap of the receiving cylinder opens. On cylinders with so-called cough valves, the cough valve also opens. Our investigations have revealed that patients may be exposed to pressure surges of around 50 to 100 mbar for short periods of time.

The scavenging and drainage systems should always be connected to the central vacuum supply first and then tested, and only after that should the connection be made to the patient. This sequence must also be followed during patient transports.

Although we can exclude the possibility of the fault occurring on the patient if the user action is carried out as stipulated, we consider it necessary to replace the AIR dual plug connectors concerned free of charge.

Please use the enclosed reply form to indicate how many of the affected dual plug connectors you have in total. We will then send you the corresponding number of new connectors promptly and at no charge (see picture).

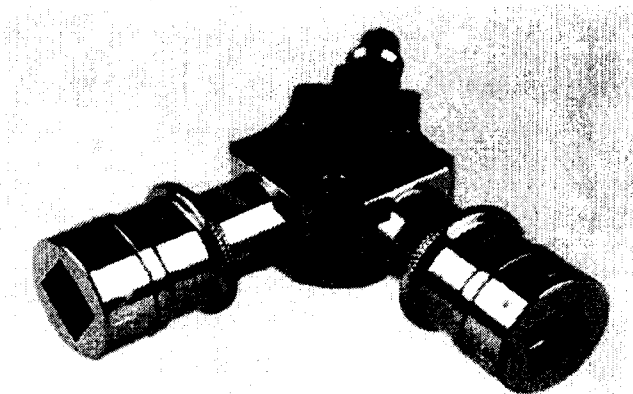
New AIR dual plug connector

On receipt of the new connectors please return the old ones to Dräger Medical, otherwise we will be forced to charge for the new issue. We hope you will understand our reasons for this, as we wish to ensure that the dual plug connectors with the fault described are not re-used. We will notify you of the return address to use when we send the replacement connectors.
