Important information for our customers

Concerned product: Mobile O.R. table 1131.12X0, BETASTAR

Subject: Application of extension plates (1131.31X0, 1131.55X0, 1132.31X0, 1132.55X0) and the transfer board 1132.65X0 at the O.R. table top

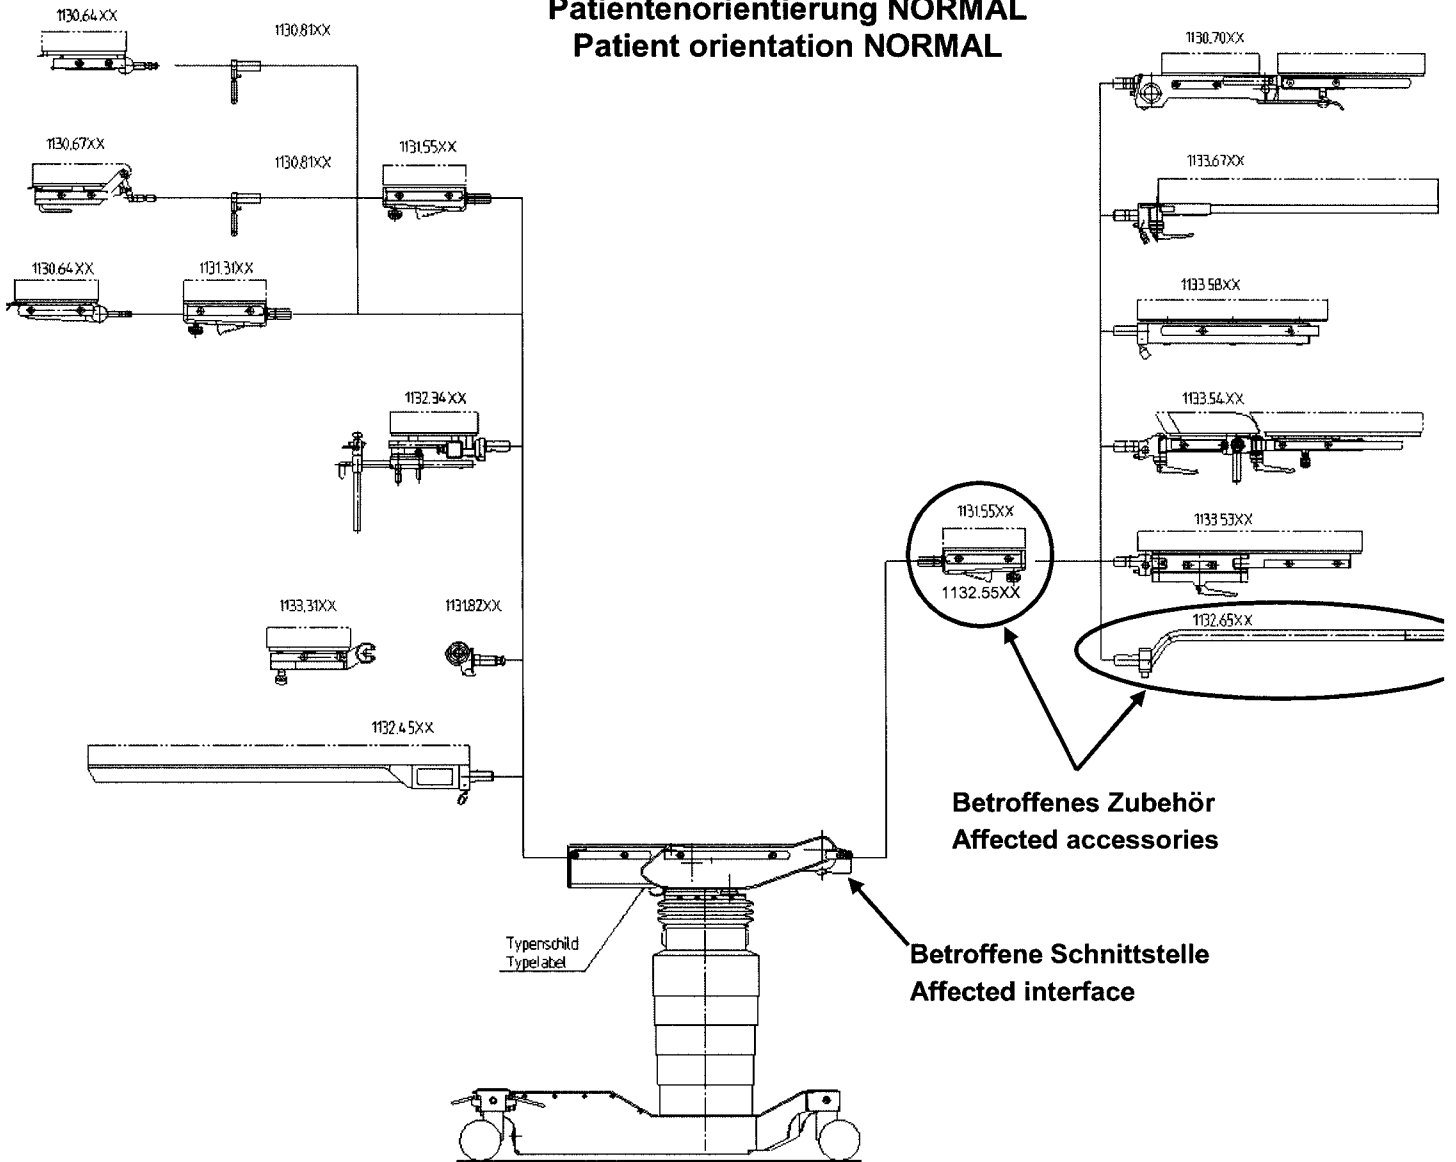
Patientenorientierung NORMAL Patient orientation NORMAL

The following pictures show accessories permitted for application with patient positioning NORMAL and REVERSE.

The described problem can only occur at the connections located above the short part part of the base and only if one of the extension plates 1131.31X0, 1131.55X0, 1132.31X0, 1132.55X0 or the transfer board 1132.65X0 is used.

To test the locking function please insert the extension plate into the connection holes up to the stop. Check to see that the locking is engaged in that you try to remove the extension plate without actuating the release levers. If the posts can be pulled out of the boreholes, the O.R. table is no longer to be used with this accessory – also if only one side does not lock properly.

The accessories can still be applied at the opposite end of the table top as these connectors are not affected by the described problem. Other accessories may be used further directly at the faulty connector holes as shown in the pictures because a different locking mechanism is used for them.
