URGENT FIELD SAFETY NOTICE

This letter is to inform you of an amendment to the field safety corrective action on the Legendair™ and Supportair™ ventilators, initiated by Covidien in March 2012, related to a potential failure of a component identified as capacitor C53.

**TSB1000014-01 Rev. B
ECO-R206600****International Technical Service Bulletin, Portable Ventilators,
Legendair and Supportair
Revised -Addendum to the Fields Safety Corrective Action**

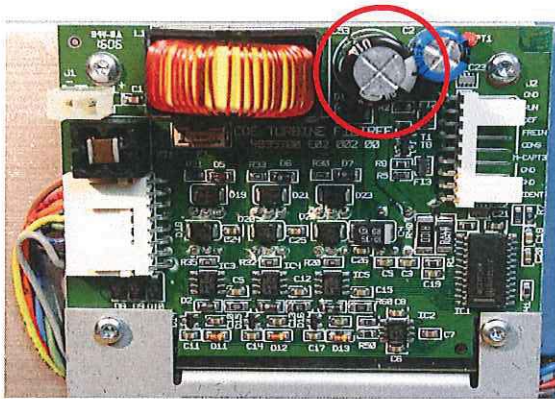
This PCB needs C53 replaced

1. The New PCB 3832799 can be installed as per the service manual
 - Legendair Service Manual Rev B. Chapter 5 page 11
 - Supportair Service Manual Rev A. Chapter 5 page 12
2. Replacement of the existing 3812799 PCB that contains a new C53 component, is done following the above mentioned service manual references.
3. Replacement of the C53 capacitor on the existing PCB can be performed by the HCP or at a Covidien Technical Services location.

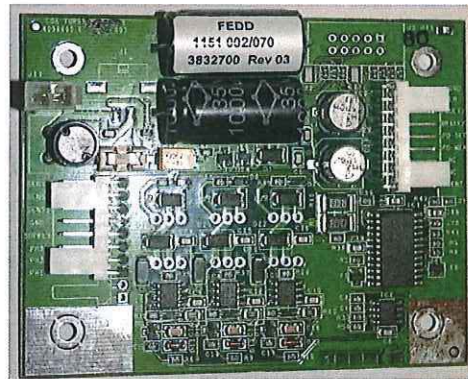
This PCB requires no action

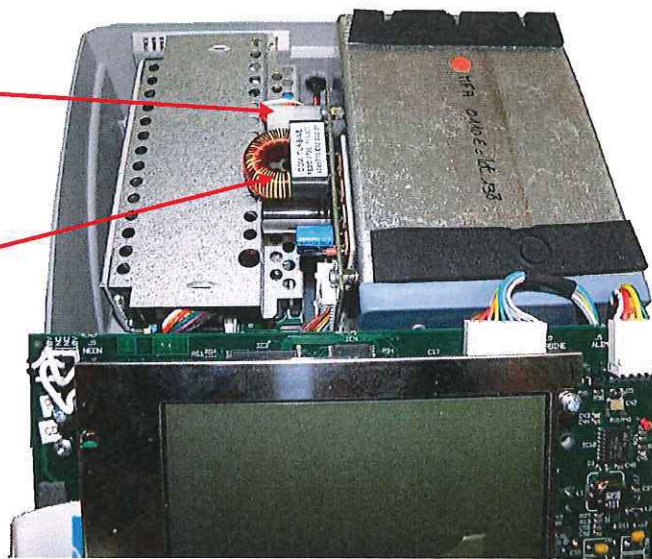
With the top cover removed the Turbine Controller PCB is located here.

The C53 is located here
