page 2 Safety Information dated 16.10.2013

We received the information that during a surgery the AIR HOSE ADAPTER ANGLED F/AESCULAP SMALL, GA508R, disconnected from the motor, GA740R, on operation.

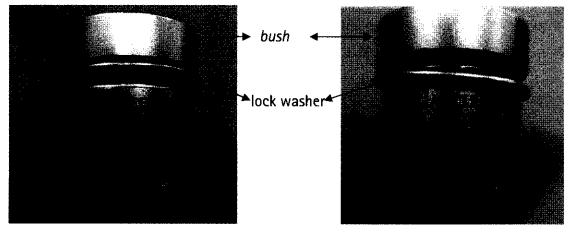
The lock washer of the adapter was deformed by the incorrect disassembling and assembling and therefore loosened, which caused the shifting of the bush. As a consequence of the shifting, the air hose adapter disconnected from the motor. Another potential consequence of the loosened lock washer and the shifted bush could be that the balls from the inside of the adapter could be freed and could fall out of the adapter.

Figure 1: Position lock washer correct

Figure 2: Position lock washer incorrect

- For the safe application of the product please comply with the instructions in the IFU.
- Please especially inspect the correct position of the lock washer. It has to be positioned free of play and in the first flute (fig. 1).
