**URGENT - FIELD SAFETY NOTICE**

**MAQUET VOLISTA  
Field Action *MSA/2017/006/IU***

| <b>Product Issue:</b> | Detachment of the central handle holder from the VOLISTA surgical light |

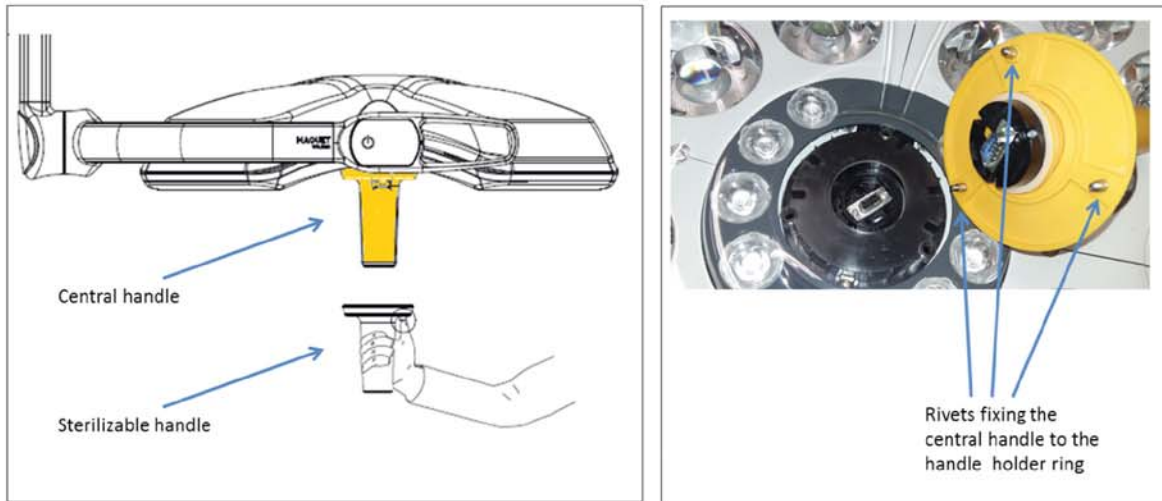
We received complaints indicating that the central handle holder detaches easily from the cupola during use. We determined that the root cause of this malfunction is excessive tightening of the screws during mounting of the handle holder, resulting in the rivets loosening and detaching from the central handle holder ring.

During manipulation, the handle holder may completely detach from the light head, if all three rivets loosen simultaneously. In this case, although the handle remains in the user's hand, small quantities of particles may be generated from the plastic holder ring. From our clinical evaluation, it was concluded that there is a remote chance that this issue may cause post-operative infection, foreign body granuloma or allergic reactions, if the particles fall into the patient's wound or on sterile equipment.

The issue was solved in production by a design change of the rivets (modification of shape and overmolding with the handle holder ring). For units manufactured before application of the modification in production, we see the issue as a potential long term hazard and want to prevent any related event from occurring with our customers. This action consists in the replacement of the existing central holder rings with the new design.
