Arnsberg (Germany), January 2018

Urgent safety information

Safety information regarding the affected products of the Aurinio L 110, L 120, L 150 and L 160, Aurinio OR lights series

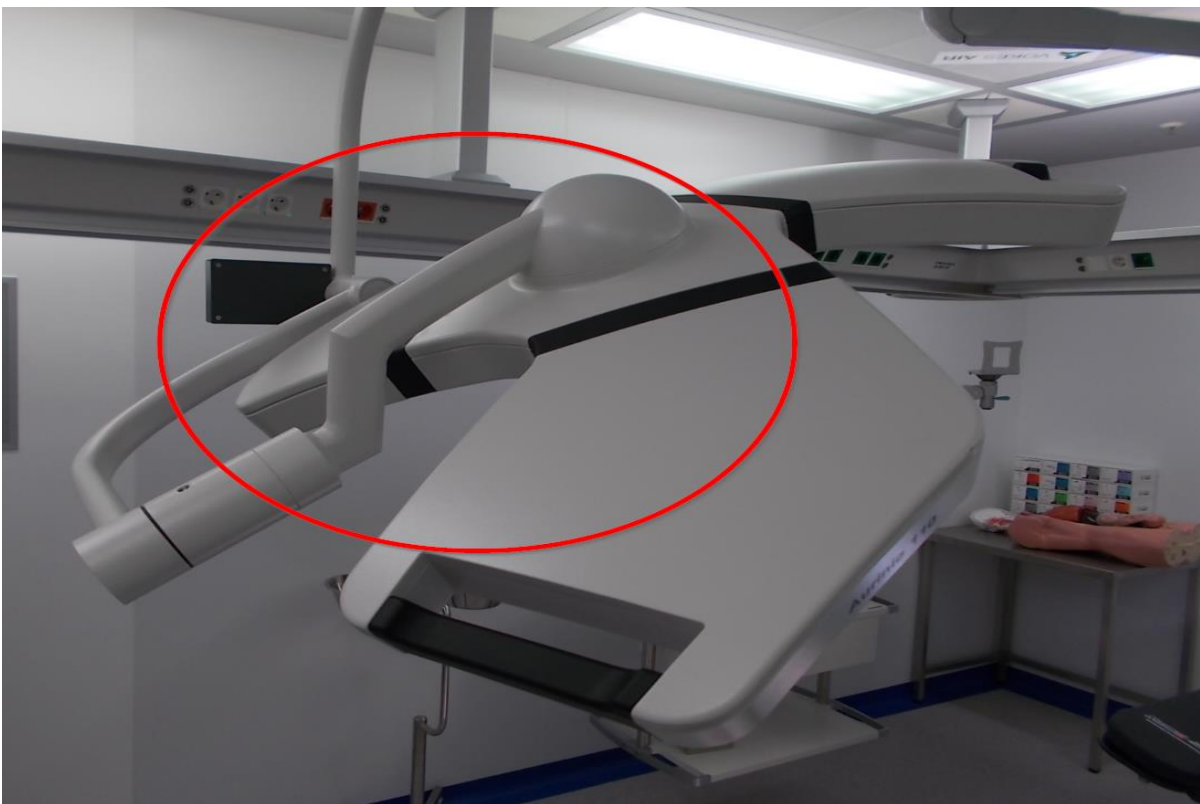
The breakage is preceded by the formation of tears in the construction, see Figure 1-3.

Figure 1: Overall system of the Aurinio OR light – affected component marked

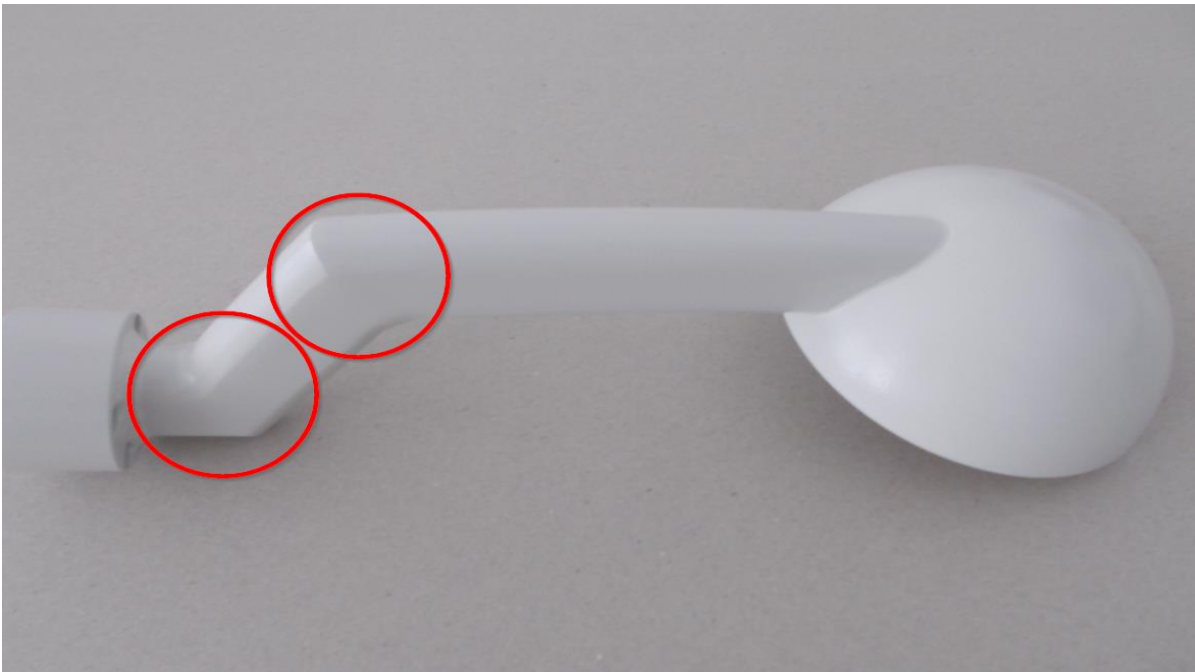
In the context of our worldwide product monitoring, we have determined that a formation of tears can occur in the support structure of the aforementioned lights. This results in a situation where the load-bearing capacity may potentially no longer be ensured and may lead to a material breakage at the welding seam of a component of our OR lights.

Figure 2: Light's connection – potentially affected areas

Until the corrective measure has been carried out, the affected component (light's connection) of the Aurinio OR light must be subjected to a daily visual inspection for a potential tear formation, in accordance with the marked areas of Figure 2.

In this inspection, please bear in mind that the inspection for the formation of tears must be carried out all around.
