## **IMPORTANT FIELD SAFETY NOTICE**

CentriMag™ Acute Circulatory Support System Motor Model: 201-10002  
*Compatible with CentriMag™ Pump and PediVas™ Pump*

September 5, 2018

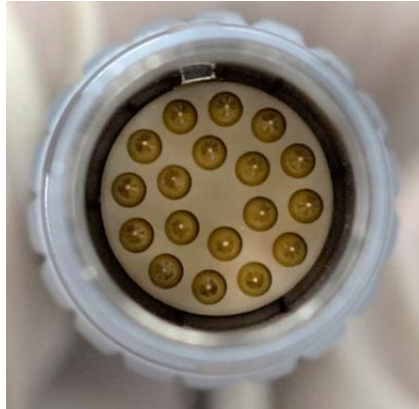
**Figure 2: Motor Connector Pin View**

- Visual inspection regarding inspection for motor cable damage from the CentriMag Circulatory Support System Operating Manual and supplemental pages (for 1<sup>st</sup> Generation Consoles)
1. Visually inspect the CentriMag Motor connector for bent or broken pins. Check for burn marks or melted plastic.

Note: If there are any issues while connecting the CentriMag Motor to the CentriMag Console, inspect the Motor port on the rear of the Console for damage, particularly for any broken pins that may be lodged inside.

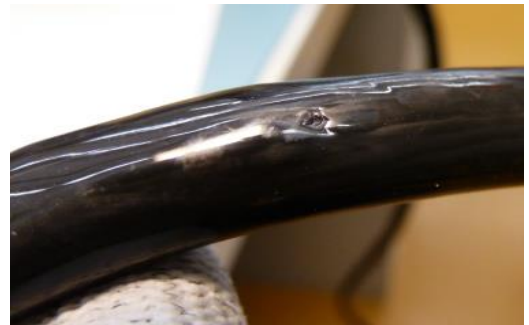
**Figure 8: Damaged Motor Cable**

Before each use, verify that the cable connecting the Motor to the Console is not kinked, which can occur with improper handling such as wrapping the cable tightly around the Motor. If the cable is kinked, replace the Motor.
