Subject: **URGENT MEDICAL DEVICE FIELD SAFETY NOTICE - CORRECTION**

Reference: **ZFA 2021-00063**

Affected Product: ROSA One 3.1 Brain application – endoscopy mode

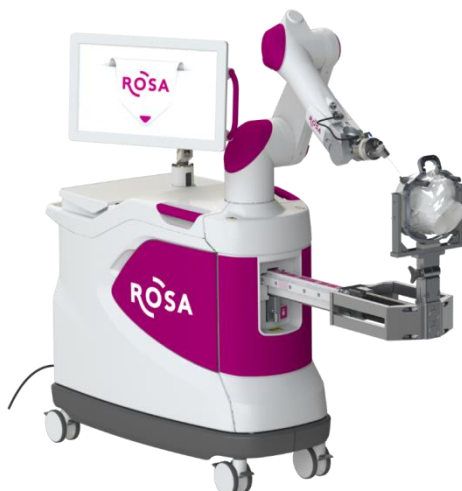
ROSA One 3.1 Brain Application

Medtech S.A - Zimmer Biomet has become aware of an event where a software anomaly affecting the endoscopy module of ROSA One 3.1 Brain application led to a transient deactivation of the security zone followed by an unexpected blockage of the robot arm.

Pending the implementation of a corrective action, Medtech S.A - Zimmer Biomet - advises that **the endoscopy module of the ROSA One 3.1 Brain application software shall not be used for surgery.**

1. Notifying affected customers of the Medical Device Field Safety Corrective Action.
2. A Zimmer Biomet engineer will be deployed to your site to deactivate the endoscopy module on your ROSA One 3.1 Brain application unit. Removal of the endoscope calibration files stops the end user from being able to execute the endoscopy surgical option and removes all the identified above risks. You will be contacted by the 30th of April, 2021 with additional information regarding this planned update and the estimated timing.
3. A Zimmer Biomet engineer will then be deployed to your site to implement a new software version to correct the issue. You will be contacted by the 31st of May, 2021 with additional information regarding this planned update and the estimated timing.
