URGENT Field Safety Notice

Trilogy EV300 and Trilogy Evo O2

XX-Jul-2021

Reference: Trilogy EV300 and Trilogy Evo O2 (2021-07-A)

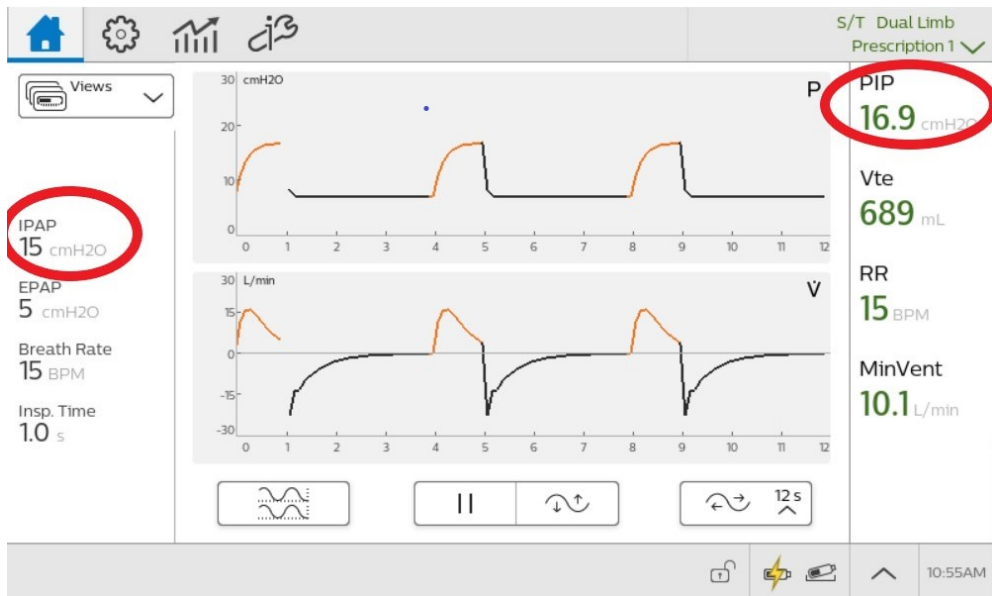
The caregiver/clinician can detect the increase in pressure by observing the measured parameters on the device's screen (measured PIP value or pressure waveform as shown below where the IPAP is set to 15 cmH₂O but because of the pressure increase the actual delivered pressure is 16.9 cmH₂O).

If a pressure drift is detected, the decision to reset the device and return to its original, intended settings MUST be made in consultation with a clinician. Take steps to support the patient during a brief interruption in therapy, as needed.

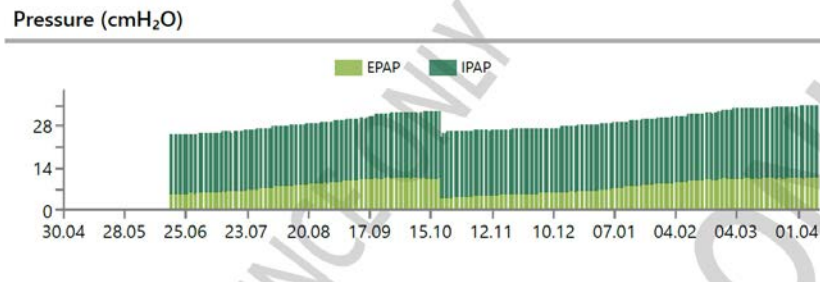
- i. The Respiratory clinician or Physician can detect the increase/decrease in pressure by observing the pressure Trend report in Care Orchestrator/Care Orchestrator Essence as shown below.

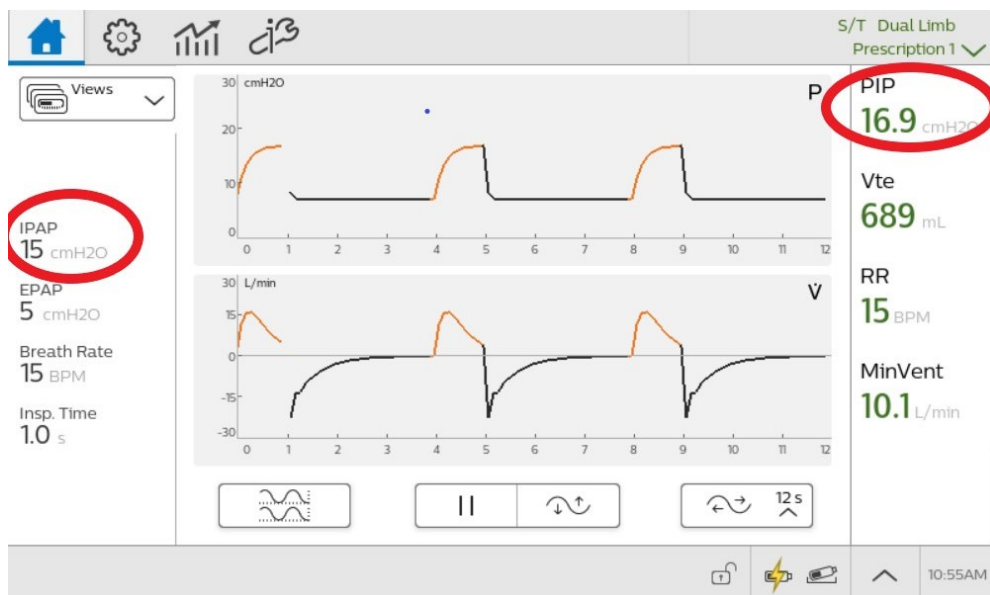
- ii. The caregiver can detect the increase in pressure by observing the measured parameters on the device's screen (measured PIP value or pressure waveform as shown below where the IPAP is set to 15 cmH2O but because of the pressure increase the actual delivered pressure is 16.9 cmH2O).

If a pressure drift is detected, the decision to reset the device and return to its original, intended settings MUST be made in consultation with a clinician. Take steps to support the patient during a brief interruption in therapy, as needed.
