# URGENT - Field Safety Notice

## Liver Assist Perfusion Set

# URGENT - Field Safety Notice (FSN)

### Quality defect – potential leakage of set

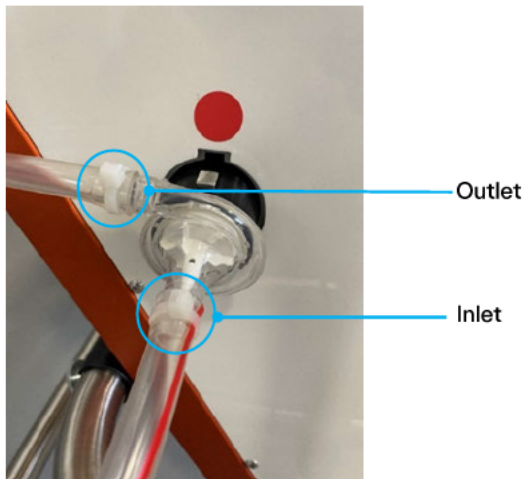
Figure 1: connections of the pump head

In rare cases, leakage could occur at the tubing connections of the pump head. Each perfusion set contains two pump heads with both an inlet and an outlet. The potential leakage can be determined already during priming when high pressures are applied. The leakage can be noticed by drop formation or persistent air bubbles at the tubing connections of the pump head

1. During priming, carefully check the connections at each pump head (4 in total). Check the inlet side for potential air bubbles in the solution or leakage. Also check the outlet side for potential leakage of solution. When handling the pump head do not extensively pull the tubing or connections.
2. If above issues are observed during priming, you can choose to replace the cable tie of the affected pump head or replace the full set.
3. If replacing the full set, save the affected set as it needs to be returned for investigation and refund.
4. If no leakages or persistent air bubbles are observed the perfusion set can be used as intended.

For an experienced user, the affected connection at the pump head can be improved by replacing the cable tie. This should take place before placing an organ on the device. Take notice that the recommended size of the new cable tie is smaller (3,5 mm instead of the current 4,6 mm).
