To our customers of the
Emergency and Transport Ventilator
Oxylog 3000 *plus*

May 2023

Important Safety Notice

Oxylog 3000 *plus* may not switch to mains supply following battery operation.

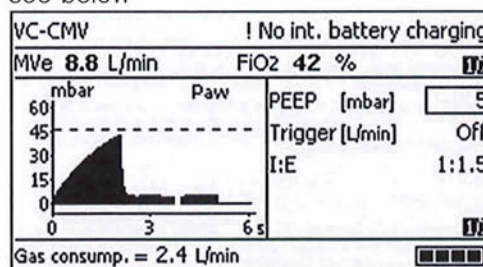
The root cause of the inability to switch to mains supply could be identified as a problem of the charging circuit which can occur in the following sequence of situations:

1. a prior battery issue indicated by the alarm "No int. battery charging" occurred during use on mains supply – see below

2. the internal battery is NOT removed and reinserted or replaced as recommended as remedy for this alarm message according to the Instructions For Use (IFU) and
3. the device is disconnected from mains supply (e.g., for patient transport) and
4. the device is reconnected to mains supply.

Please make sure that the battery is always removed and reinserted or replaced after occurrence of the **"No int. battery charging"** alarm message, without removing the device from mains supply.

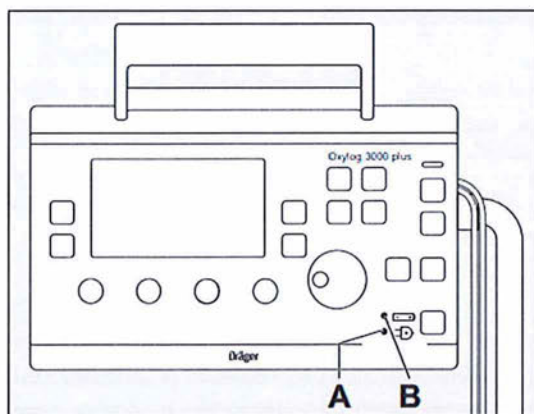
Prior to a device being used on a battery supply, ensure the correct switchover by disconnecting from and reconnecting the device to a mains supply. Please verify the colors of indicators A and B as per the diagram below:

A should display a green light, and B should display a green or yellow light. If B displays a red light, you should disconnect and reconnect or replace the battery.

Your local Dräger Service representative or our service partner will contact you to arrange a date for a firmware update of the Printed Board Assembly Charger to be performed free of charge.
