**URGENT FIELD SAFETY NOTICE
MEDICAL DEVICE CORRECTION
FSCA 2249723-05/05/2023-008-C**

Datascope Cardiosave Hybrid and Rescue Intra-Aortic Balloon Pumps (IABP)

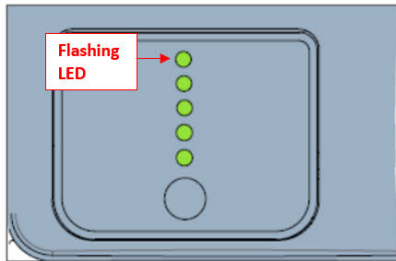
Figure 1: Battery is 80% - 100% Charging

Do NOT remove battery

To prevent electrical surges that may impair the Cardiosave's ability to charge batteries, **do not remove the battery** from a Cardiosave **when the battery level is at 80% or higher and actively charging** (i.e. successfully connected to AC power). Keep the battery in the charging bay until fully charged.

Each Battery has five (5) LEDs indicating the battery's approximate state of charge. **A battery with 80% charge is represented by four (4) solid illuminated LEDs and when charging, the topmost LED on the battery will be flashing. Removing the battery when the top LED is flashing during the charging operation may result in damage to the Cardiosave's battery charging circuitry.**

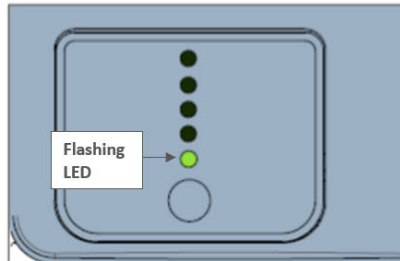
Figure 2: Battery 0%-20% Charging

Safe to remove battery

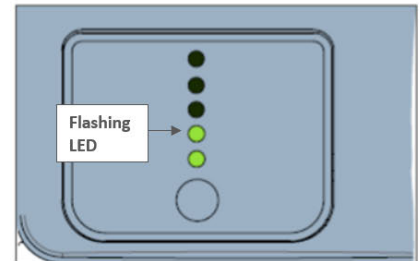
Figure 3: Battery 20%-40% Charging

Safe to remove battery

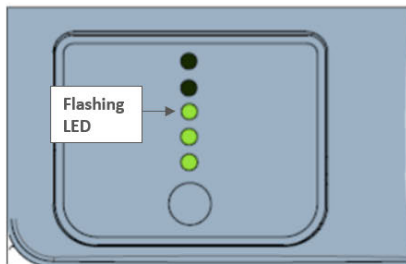
Figure 4: Battery 40%-60% Charging

Safe to remove battery

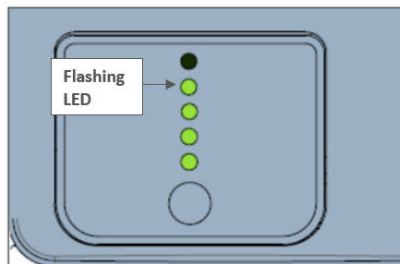
Figure 5: Battery 60%-80% Charged

Safe to remove battery

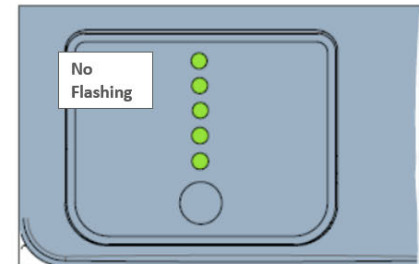
Figure 6: Fully Charged Battery

Safe to remove battery
