## URGENT FIELD SAFETY NOTICE MEDICAL DEVICE CORRECTION FSCA 2249723-06/02/2023-009-C & FSCA 2249723-06/02/2023-012-C

Datascope Cardiosave Hybrid and Rescue Intra-Aortic Balloon Pumps (IABP)

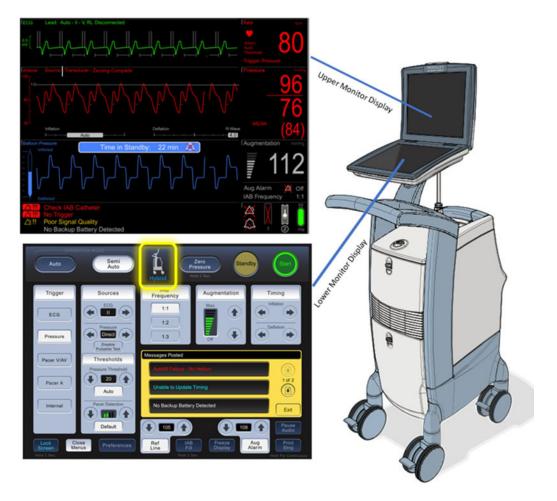
#### Cardiosave Upper and Lower Display

In both cases, information is provided to the user that the system is not in Hybrid mode via the Rescue Mode Icon on the bottom Cardiosave screen (top center of the screen). In addition, the "battery in use" message will be displayed in the informational message area even if the AC power cord is plugged in.

Additionally, in both scenarios, the Cardiosave will not receive AC power and if the device is in operation, it will continue to operate on battery. When the Cardiosave is not receiving AC power, the batteries are unable to charge.

If the AC Plug Icon is not present and/or the Rescue Icon is present, release the latch on the Hospital Cart located below the Pump Console, then grab the handle and slowly slide out the console approximately one quarter of the way.

Grab the handle and slowly slide the Pump Console into the Hospital Cart until it locks into place. You will hear an audible click noise and three audio tones of increasing volume will sound once the console is locked into the Hospital Cart.

To ensure the Pump Console was successfully installed into the Hospital Cart, plug the Hospital Cart power cord into a compatible grounded AC receptacle, and confirm AC operation by checking the battery icon to confirm the pump is using AC power.
