**URGENT FIELD SAFETY NOTICE  
 MEDICAL DEVICE CORRECTION**  
**FSCAs 2249723-06/02/2023-010-C, 2249723-06/02/2023-011-C,  
 2249723-06/02/2023-013-C & 2249723-06/02/2023-014-C**  
**Datascope Cardiosave Hybrid and Rescue Intra-Aortic Balloon Pumps (IABP)**

Datascope Corp., a subsidiary of Getinge is initiating a voluntary Medical Device Correction for the Cardiosave Hybrid and Cardiosave Rescue Intra-Aortic Balloon Pump (IABP) due to the following four (4) identified system conditions:

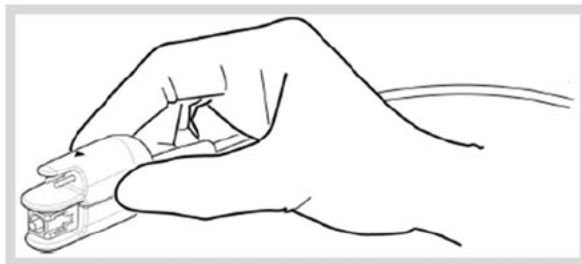
Figure 2-5: Grasping the Fiber-Optic sensor connector

The Fiber Optic connector is designed to fit smoothly into the IAB Sensor Input. The red triangle on the top of the connector should align with the red triangle on the Cardiosave console. Inserting the Fiber Optic connector into the port without verifying the correct alignment can lead to internal damage. If difficulty is encountered when inserting the connector, verify that the connector is in the correct position and attempt to reinsert into the IAB Sensor Input.

Excessive force can cause damage to the connector and the internal fiber optic assembly of the IABP console. This may cause a disruption in the fiber optic signal acquisition resulting in an inability to acquire a fiber optic signal on the Cardiosave IABP. Following proper insertion procedures will minimize the potential for damage to the connector and a loss of signal. This conclusion is based on field observations seen through the complaints evaluation. As part of Datascope's investigation testing will be performed to confirm this observation.

Ensure that the red triangles on the Fiber-Optic IAB Sensor Connector and on the back panel are in alignment.

In step 4, when the Fiber-Optic connector is inserted into the IAB Sensor input until an audible “click” is confirmed, ensure that you are not using excessive force as that can lead to damage to the Cardiosave.
