25. August 2023

**FIELD SAFETY NOTICE**  
**for Distribution Partners of**  
**Hamilton Medical In2Flow Nasal cannulas**  
**Reference #: FSCA 2023-08-04**

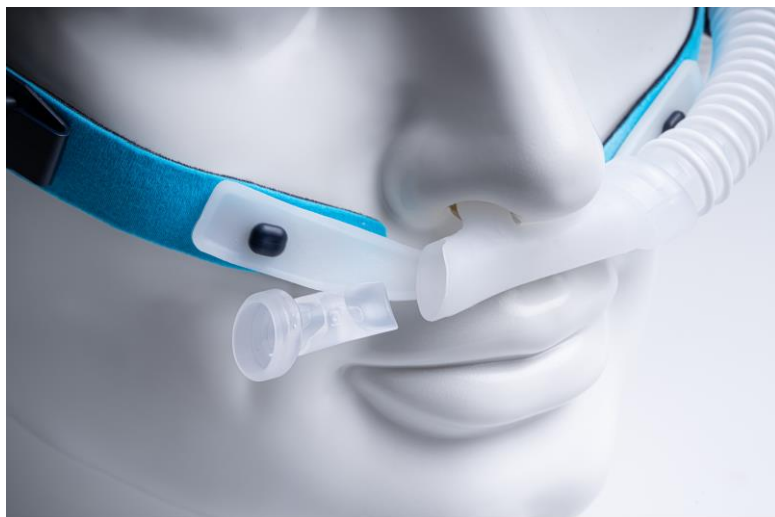
Hamilton Medical AG is informing about a potential health risk when using the In2Flow Nasal cannula after receiving reports that the plug became detached from the soft part as shown in Figure 1.

**Failure description:** Several complaints were received where the plug (the one at the opposite side of the tubing) became detached from the In2Flow Nasal cannula, causing leakage due to unintentional disconnection of that part. This may result in degraded high flow support and oxygen delivery, which may lead to patient O2 desaturation.

*Figure 1: An In2Flow Nasal cannula size M is shown. The plug became detached from the opposite side of the tubing. (This is an example; sizes S and L are also affected.)*

<b>Failure effect:</b>	In case the plug becomes detached from the In2Flow Nasal cannula during high flow therapy desaturation of the patient with SpO <sub>2</sub> < 80% might result.
<b>Affected Devices:</b>	<p>Hamilton Medical AG In2Flow Nasal cannula of all sizes and all lot numbers are affected.</p> <p>Product numbers of affected devices:</p> <p>In2Flow Nasal cannula, size S: 10076606</p> <p>In2Flow Nasal cannula, size M: 10076605</p> <p>In2Flow Nasal cannula, size L: 10076604</p>
<b>Patient risks:</b>	If health care staff does not detect and solve the issue within a short period of time (minutes), this might result potentially in prolonged O <sub>2</sub> desaturation and thus in serious deterioration in state of health of patients.
<b>Required user actions if failure occurs:</b>	<p>In case desaturation is identified, perform as required:</p> <ol style="list-style-type: none"><li>1. Keep monitoring patient's O<sub>2</sub> saturation and act accordingly.</li><li>2. Check if plug of In2Flow Nasal cannula became detached.</li><li>3. If the plug is still in place, check for other reasons for O<sub>2</sub> desaturation.</li><li>4. If the plug became detached, exchange the affected In2Flow Nasal cannula, and use a new In2Flow Nasal cannula.</li></ol>

<b>Preventive actions:</b>	Use additional independent monitoring devices, including pulse oximeters measuring SpO <sub>2</sub> , at all times. (As indicated in the Instructions for Use, Document 10083250/02.)
<b>Additional actions to be taken by distribution partners:</b>	<ul style="list-style-type: none"><li>• Distribution partners are requested and obliged to notify the local authorities if Hamilton Medical AG has not already done so. The report to the local authorities must be made in accordance with your local regulations, but no later than 10 working days after the receipt of this safety notification. Please contact <a href="mailto:vigilance.med.global@hamilton-medical.com">vigilance.med.global@hamilton-medical.com</a> if you have any further questions regarding reportability. The evidence, that the local authorities have been informed, must be filed in the prepared TASK 2 of ky2help.</li><li>• Translate the End-Customer FSN to your local language, where applicable, and send it to the affected end-customers immediately.</li><li>• Collect the confirmation sheets from end customers. File the documents locally. This must be completed by 04. October 2023.</li><li>• If the end customer does not respond promptly, the distribution partner must send and document at least three attempts to obtain feedback from the end customer. If the end customer does not provide a response, document internally, and no further action needs to be taken with respect to this end customer.</li></ul>
