Urgent Field Safety Notice**Field safety corrective action****concerning****Ceiling Unit CU 5001/3 and CU 3-21/23****for ceiling mounted operating microscopes manufactured by MÖLLER-WEDEL**

xx.02.2017

Identification of affected medical devices

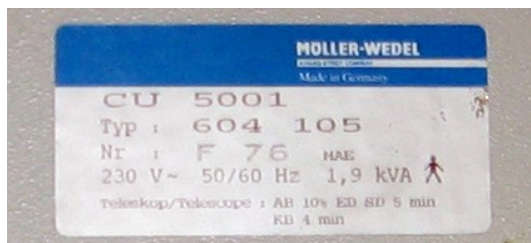
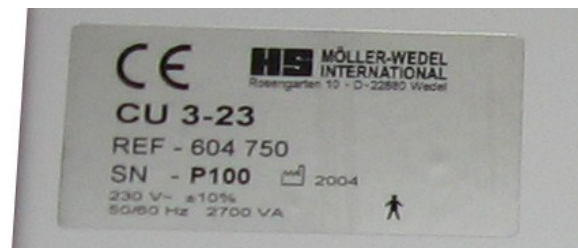
Identification:

Identification plate with reference number (REF/Typ) and serial number (SN/Nr)
on the upper edge of the ceiling body

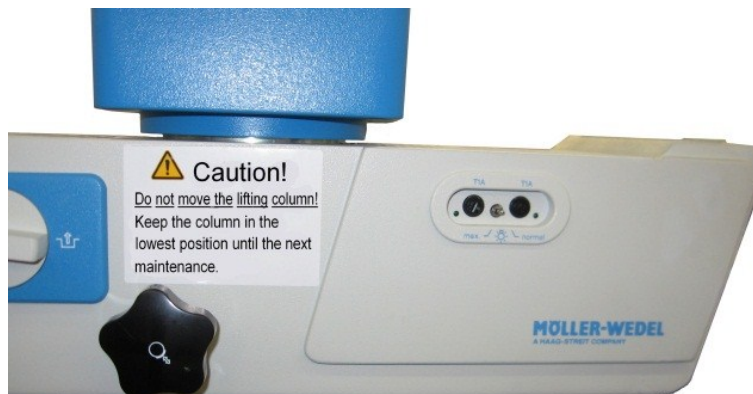
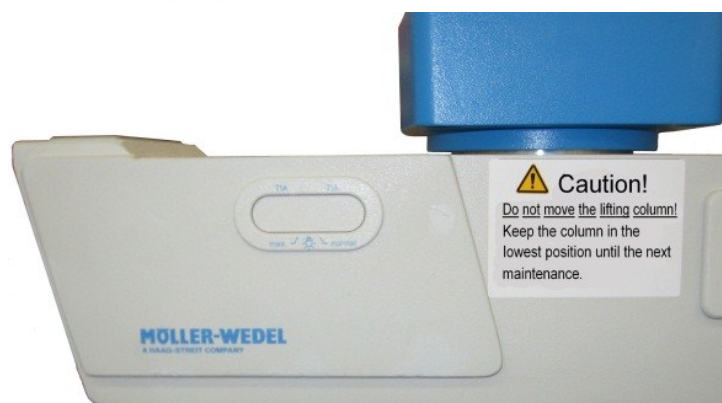
Labeling:

2x labels on the left/right underneath the column

1. Move the telescope column to the lowest position. The ceiling unit is now in the safe working position and can be used without restrictions.
2. Keep the ceiling unit in the lowest and thus safe working position until the ceiling unit has been serviced.
3. Use the enclosed labels on the ceiling unit to indicate that the lifting column is not to be used anymore (see annex).
4. Order the maintenance of your ceiling unit at your local representative office.
5. Please return the enclosed reply form to us as soon as possible.
