FIELD CORRECTIVE ACTION NOTICE

Leica M525 F20 Microscope System

FCA Identifier: CAPA-HER-MD-18-001

Enhancement of instructions for use and additional markings to prevent inadvertent tipping

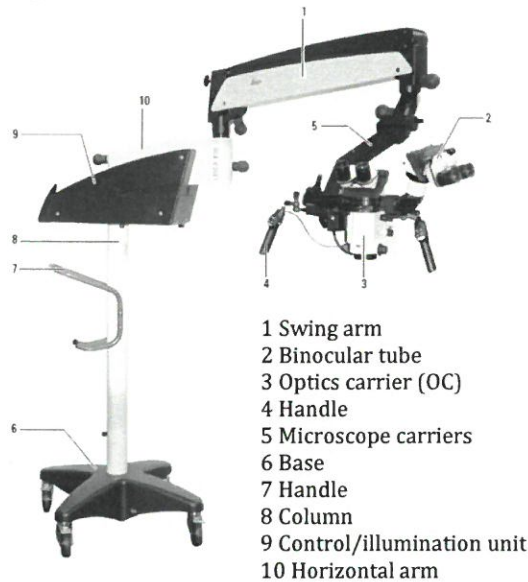
Figure 1: Overall view of Leica M525 F20 Microscope

Leica Microsystems received five customer complaints stating that users inadvertently tipped over their Leica M525 F20 Microscope System. In four cases it was confirmed, that the issue occurred when users handled the microscope while the swing arm was in fully extended position (see Figure 3). In all cases the Leica M525 F20 did not cause or contribute to serious injury. The five complaints occurred in five different countries over a timeframe between the years 2010 and 2017. The Leica M525 F20 was introduced in the year 2009 with more than 1000 instruments distributed globally up to date.

This letter is to inform you about a field corrective action involving all Leica M525 F20 Microscope Systems (see Figure 1) to replace the instructions for use with an enhanced revision and to fix additional markings onto the device.

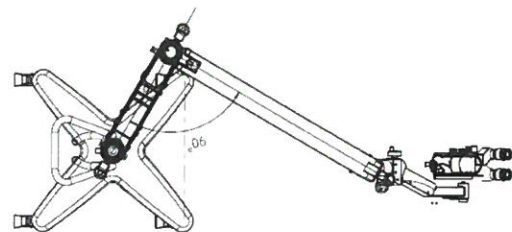
Figure 2: Top view of Leica M525 F20 Microscope

Intended correct positioning:

~ 90° between horizontal arm and swing arm

- You can continue to use the system pending availability of the enhanced user manual and the additional markings as described in Attachment 1:
 - Ensure that your Leica M525 F20 is positioned and handled with an angle of approximately 90° between horizontal arm and swing arm during surgery as well as during set-up and preparation (see Figure 2 and Attachment 1).

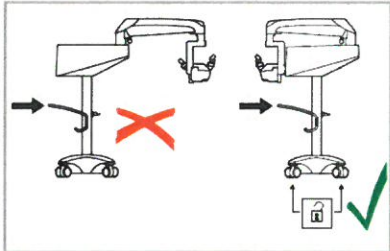
<p>Never move stand in the extended position.</p>

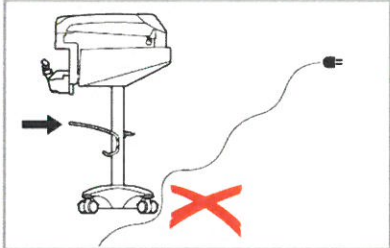
<p>Never roll over cables lying on the floor.</p>

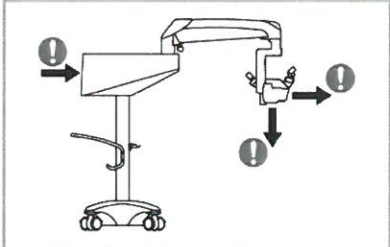
<p>Do not allow vertical and horizontal forces to the stand in the extended position.</p>

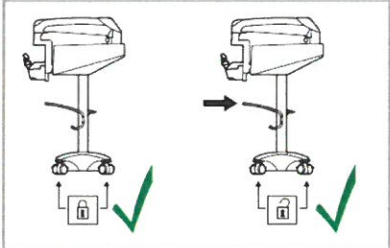
<p>Always lock the foot brake when you are not moving the system. Always open the foot brake when you are moving the system.</p>

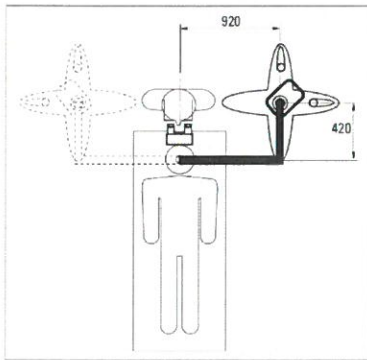
Figure A: Intended positioning- Option 1

The enhanced revision of the Leica M525 F20 instruction for use will describe the intended positions of the Leica M525 F20 in the OR as shown in Figure A and B below.

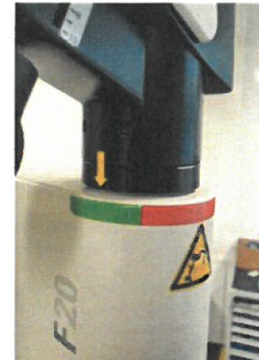
Figure C: Scale Indicator

An additional marking with a scale indicator and arrow as shown above in Figure C will assist Leica M525 F20 users to position the horizontal arm and swing arm with as intended with an angle of approximately 90°:

- The yellow arrow pointing to the green area shows that the device is set up as intended.
- The yellow arrow pointing to the red area shows that the device is not set up as intended and special care is needed to prevent inadvertent tipping when handling the device.

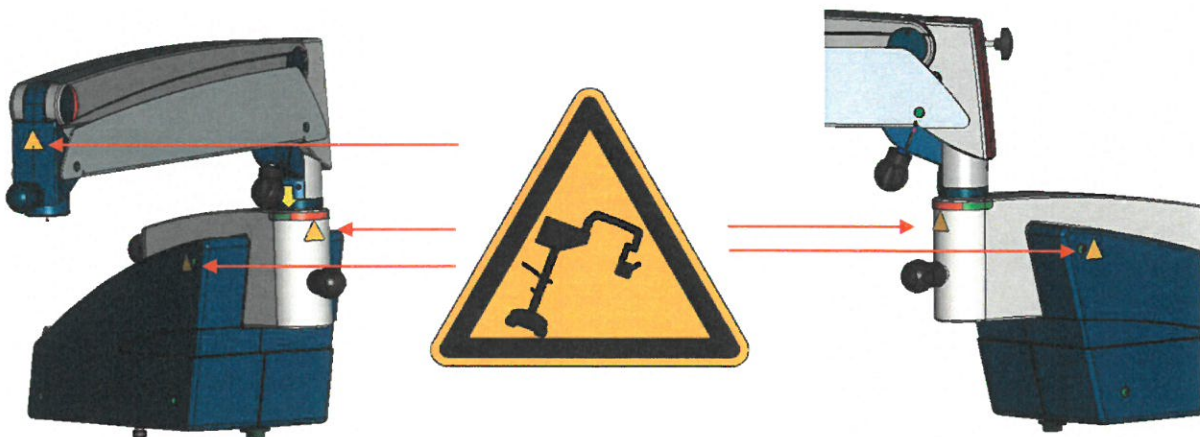
Figure D: Position of new Warning Label

Figure E: New Warning Label

Figure F: Position of new Warning Label

Four additional warning markings (see Figure E) will be placed on the Leica M525 F20 to make users aware of tipping hazards when handling the device as shown below in figure D and F:
