Customer Advisory Notification

Addressees: User of Philips MammoDiagnost Systems

Applies to: All MammoDiagnost Systems

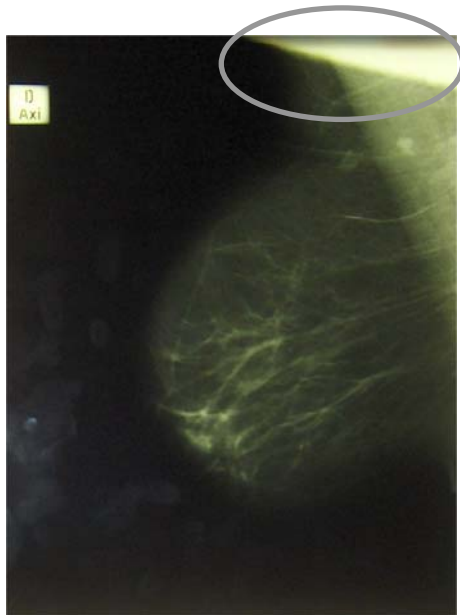
During our regular quality check we encountered that in rare cases white shadow may appear at the edge of the mammography image. This shadow occurs due to incorrect positioning of the filter wheel in the tube head of the system. If this problem should occur with your system, the affected image might not allow conclusive viewing and in this case has to be re-acquired.

An example of this shadow is shown below:

If your system is affected by this problem, it has to be corrected during an on-site visit by a Philips service engineer. Therefore, we kindly ask that you notify your Philips Service representative immediately in case you observe this problem. This service will be free of charge.
