FSN S/N: 20071125

Date: Nov 25 2007

URGENT - Field Safety Notice MX4000, MX4000 Dual, MX6000 Dual

Mis-labeled image that may result in incorrect diagnosis

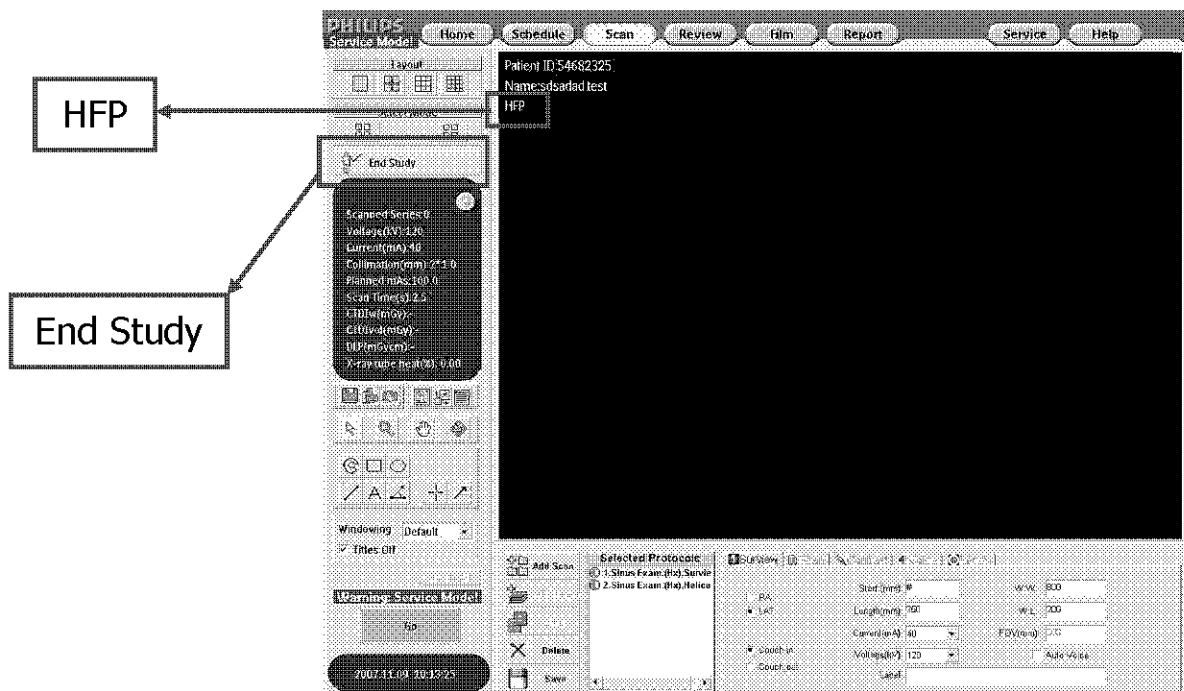
4. Patient Scanned Interface, the patient indicator will show "HFP". Then click "End Study", return to Worklist interface:

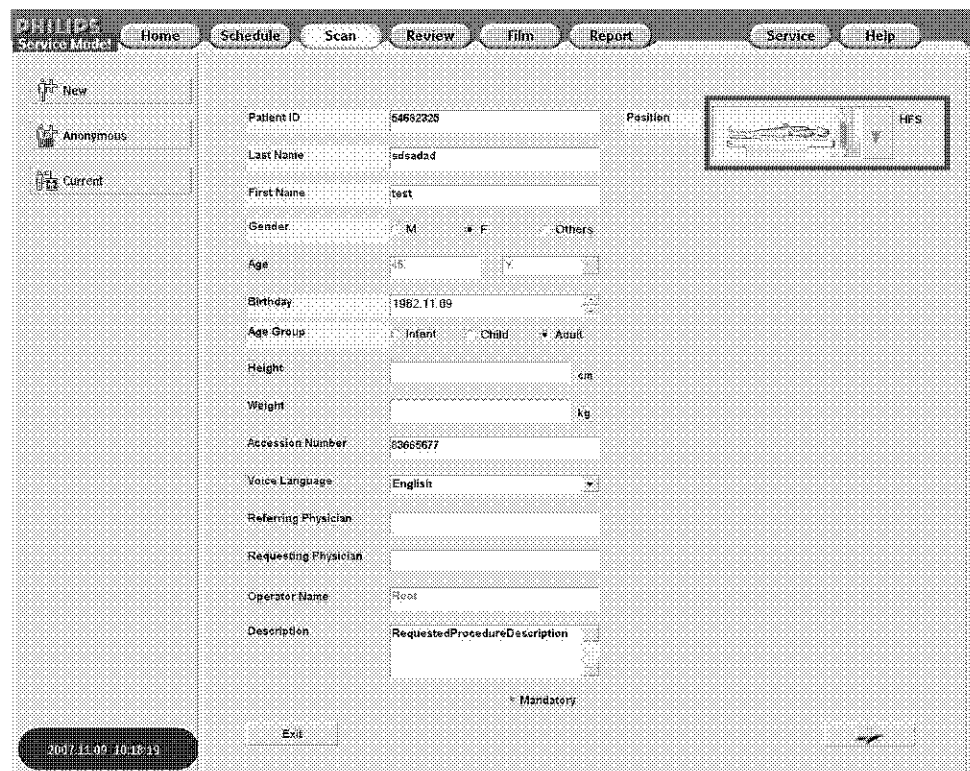
6. Enter patient register interface, Change patient position to "HFS".

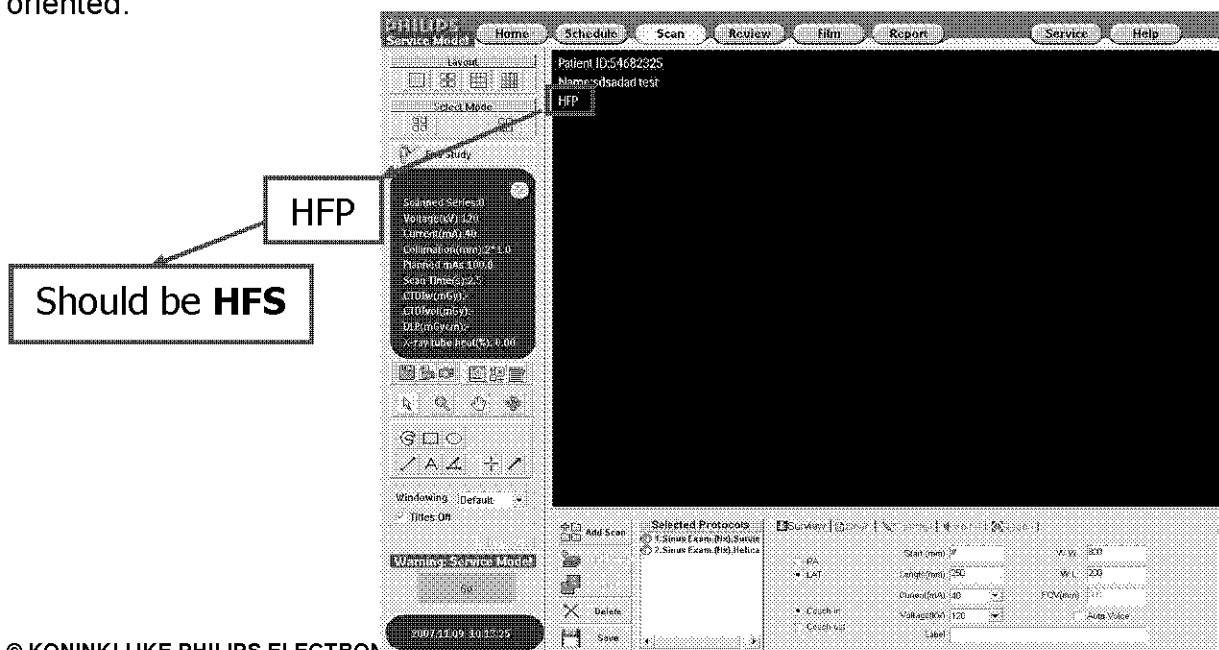
8. Enter Patient Scanned Interface, the patient position remains "HFP". If the user would have ignored this indication and completed the scan, the image generated will be mis-oriented.

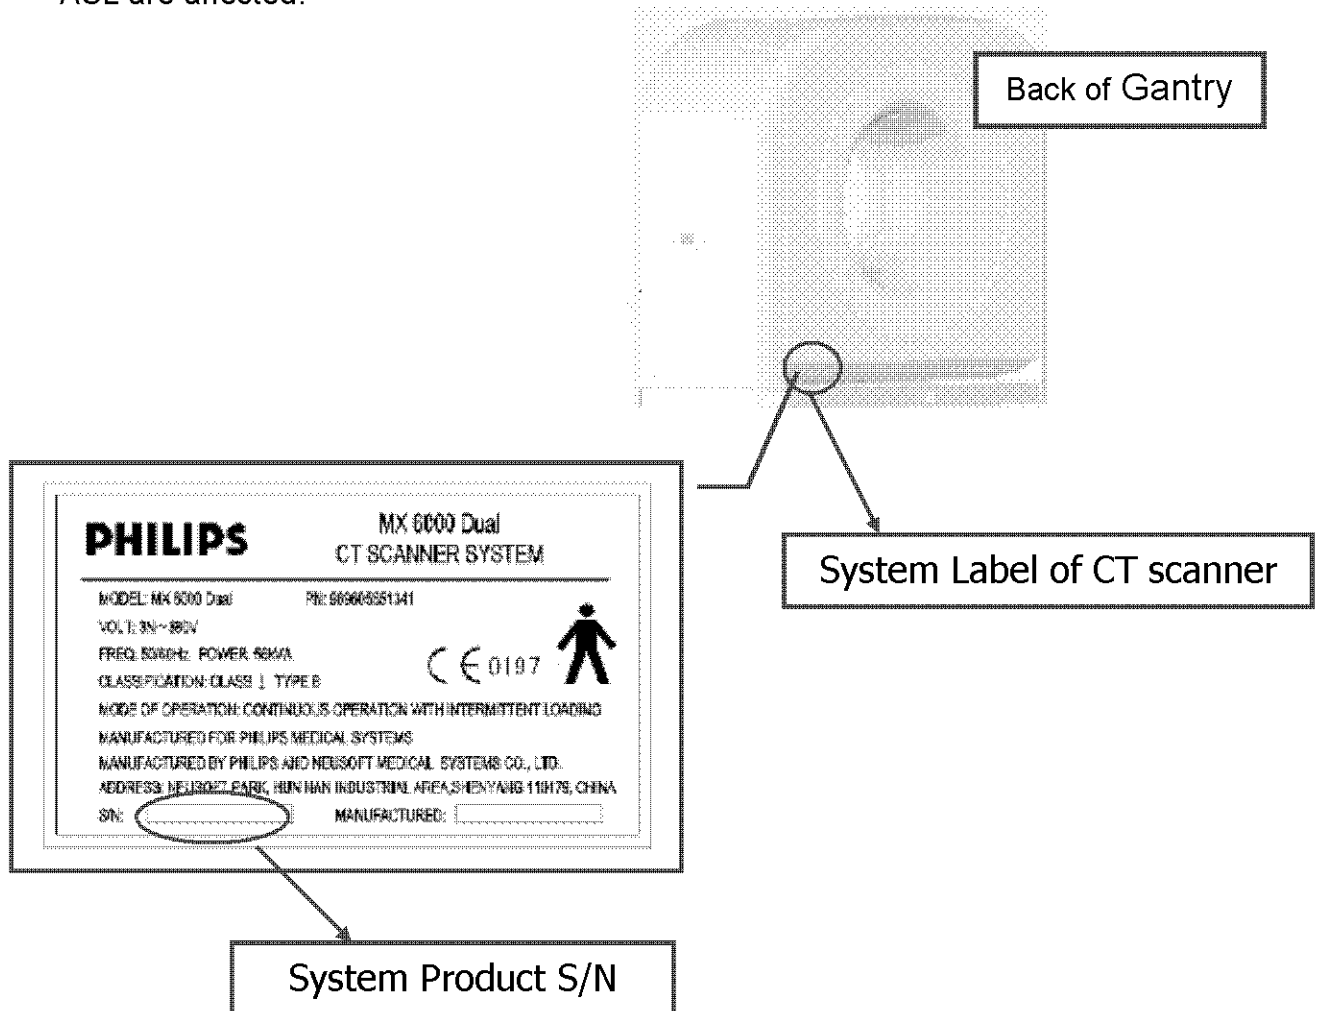
1. Locate the system label at the left bottom corner of the backside cover.
2. Read and record carefully the product S/N. Systems with an S/N that is listed in the ASL are affected.
