# Field Safety Notice

FSN S/N: 20080404

## URGENT - Field Safety Notice MX4000, MX4000 Dual, MX6000 Dual

### Malfunction of "Timed Scan" may result in unnecessary X-ray

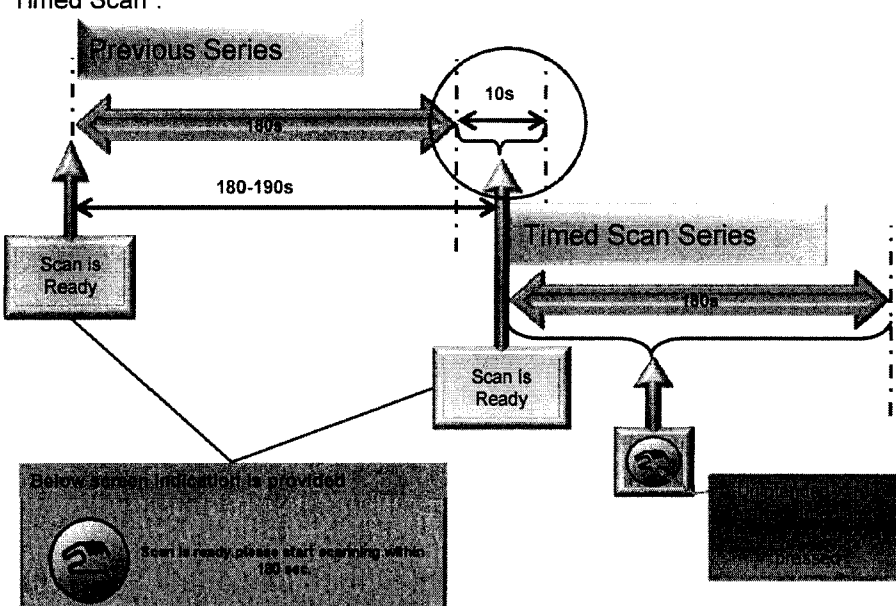
<b>AFFECTED PRODUCTS</b>	<p>See <b>Affected System List</b> attached as <a href="#">Annex A</a>                  The affected product model are identified by Product no. as follows:  <b>MX 4000</b> (Product no. MCU 1731), <b>MX 4000 Dual</b> (Product no. 989605651351), <b>MX 6000 Dual</b> (Product no. 989605651341)</p>
<b>PROBLEM DESCRIPTION</b>	<p>An issue associated with "Timed Scan" application was found. After investigation it was concluded that the problem will affect MX series CT products (MX 4000, MX 4000 Dual, MX 6000 Dual scanners).</p> <p>The "Timed Scan" function is supposed to allow the operator to program a time delay for initiation of scanning. The system does not wait for the programmed time interval and starts X-ray after selection of the scan button when all below 3 criteria's are met.</p> <ol style="list-style-type: none"> <li>1. A "Timed Scan" series occurs after one or multiple scan series;</li> <li>2. Time span between two "Scan is ready" indications is within 180-190 seconds;</li> <li>3. Scan button is pressed within 180seconds after the "Scan is ready" display of "Timed Scan".</li> </ol>

<p>The system provides audible and visual indications when a scan starts with X-ray, therefore the unintended X-ray can be detected and stopped by the doctor/operator to prevent excessive radiation.</p>

<b>ACTION TO BE TAKEN BY CUSTOMER / USER</b>	Users must follow the instruction below in order to avoid this issue: <b>Ensure a minimal 3 minutes (180 seconds) interval between the two time points below:</b> <b>1. The images reconstructed of preceding series is completed.</b> <b>2. Click "Go" on the screen to start a "Timed Scan"</b>
<b>ACTIONS PLANNED BY Philips Medical Systems</b>	Philips will correct all affected systems free of charge by means of a software upgrade. Implementation is planned to start in June 2008. You will be contacted by your Philips representative for the planning of the software update
<b>FURTHER INFORMATION AND SUPPORT</b>	If you need any further information or support concerning this issue, please contact your Philips Medical Systems Service Support Department.

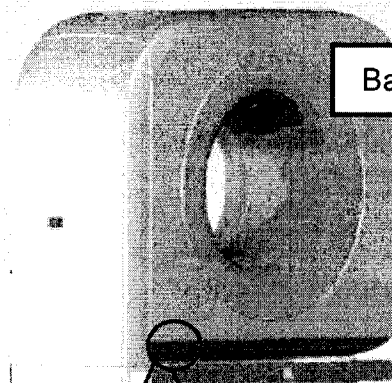
Back of Gantry

1. Locate the system label at the left bottom corner of the backside cover.
2. Read and record carefully the product S/N. Systems with an S/N that is listed in the ASL are affected.

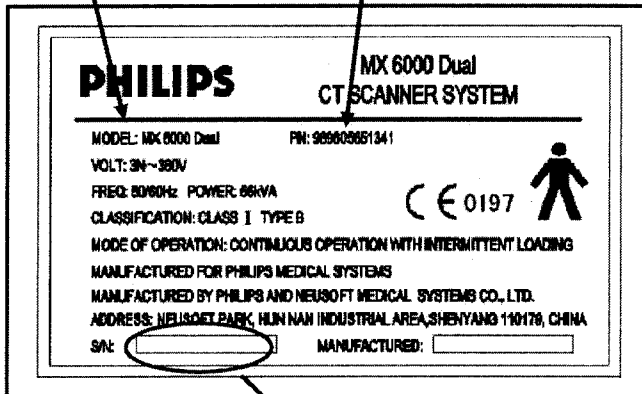
System Label of CT scanner

Product S/N
