GF Healthcare

GE Healthcare Ref: FMI 12129

RE: Seno Advantage Workstation 1.x: Inaccurate measurements on magnification views acquired on non-

GE digital mammography systems.

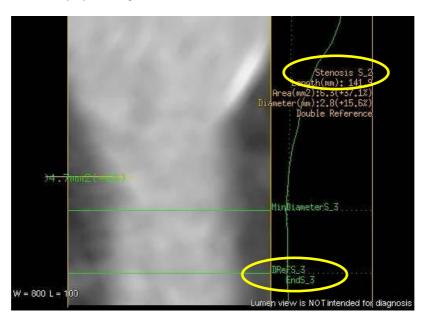
On Volume Viewer 3 version vxtl_7.x, the stenosis / aneurysm number corresponding to the measurement values in the lower right corner of the image will not match the number of the stenosis / aneurysm graphically displayed on this same image. As the identification of the finding differs only by one digit, the user can miss this information.

- Deposit only one stenosis / aneurysm measurement at a time.
- When analyzing multiple locations, delete the first stenosis measurement before placing the next stenosis measurement.

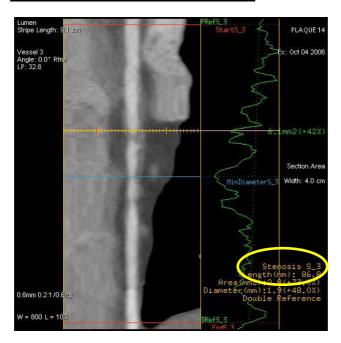
Before the first measurements are removed

On Volume Viewer 3.1 version vxtl_8.1, the stenosis / aneurysm measurement points will be moved to another vessel location / a different vessel other than the one the user originally selected. The measurements will match the new vessel anatomy, but they will differ from the original intent of the user.

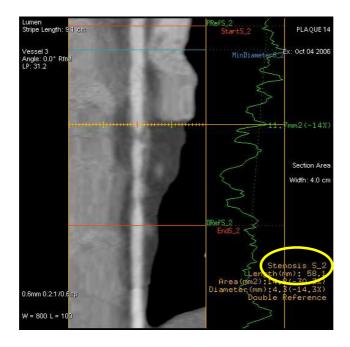
After the first measurements are removed:
Stenosis # 2 from Vessel # 2 replaced Stenosis # 3

In the worst case, a mismatch of measurement annotations in Lumen view could lead the caregiver to underestimate vascular diseases (e.g. stenosis and aneurysm), which could lead to a potential missed diagnosis.

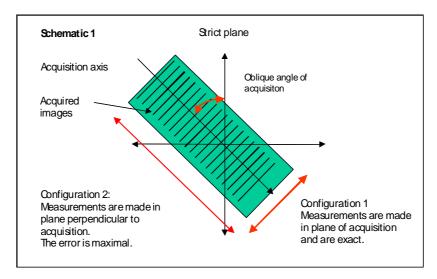
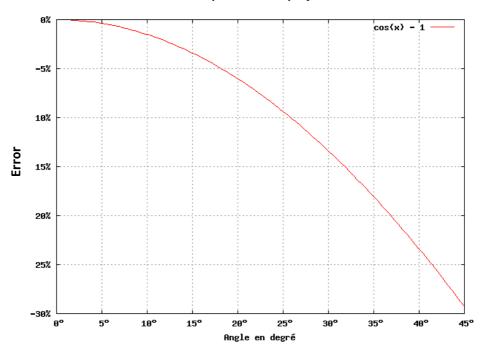
Curve C: Variation of the error as a function of the angle of obliquity of acquisition

Reconstruction in 3D made from this type of acquisition using Volume Analysis or Volume Viewer has the following fault: reconstructed volumes appear compressed in comparison to their real size. This causes an error in the measurements made on a plane that is different from the acquisition plane. This error does not appear on the native images.

Note that the deformation depends on the acquisition angle in relation to the closest axial, sagittal or coronal plane according to the formula 1- cosine (angle), as well as by the orientation of the reformatted images in relation to the acquisition axis. The maximum value of the deformation is 30%: this is reached for an acquisition angle of 45 degrees in relation to a main plane, and the measurement error is maximum when the measurement plane is perpendicular to the acquisition plane.

Graph showing the percentage error as a function of the angle of the acquisition plane and in the most penalizing condition of measurement that is, for a measurement made on a plane perpendicular to the plane of acquisition.

- Make acquisitions in the strict axial, sagittal or coronal planes, i.e., without incline in relation to the reference planes.
- For therapeutic follow-up with comparison of exams, if it is necessary to make exams in the oblique plane, specify the angle of acquisition in relation to the table to the same value as used in the reference exam. This approach is not recommended, however, because it is difficult to find exactly the same angle from one exam to another.

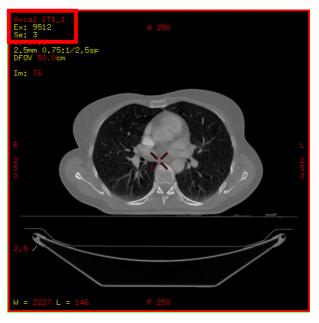
AdvantageSim MD supports loading multiple image sets from an examination at the same time. When several non-phased series are loaded simultaneously, there is a possibility that they can be mislabeled, with the result being that incorrect model and series numbers are on the displayed images. The Radio Therapy Structure Sets (RTSS) generated using mislabeled series will most likely be rejected by the radiation treatment planning system. If they are not rejected by the system, the non-phased data used for treatment planning might be confused with each other, causing errors in radiation treatment planning.

In the right image above, the "CT1_1" Model Number (top left corner, line 1 in red) is shown as corresponding to Series Number "3" (top left corner, line 3 in yellow) instead of "552" as shown in the Series Panel (left image above). This is incorrect.

As a preventive action, GE Healthcare recommends that the user load non-phased series one-by-one into AdvantageSim MD.

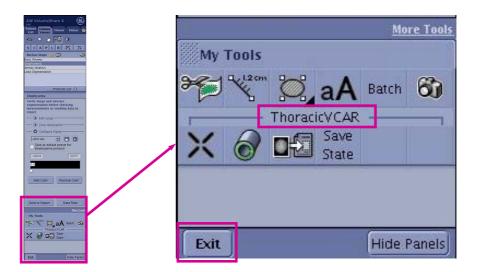
If the user did not exit the application, the correct imaging study will appear and the data on the summary table will contain the results of the current patient imaging study; however, the previous patient name will be displayed on the summary table. This summary result may be separated from the remainder of the CT imaging exam if it is printed on film or paper and incorrectly inserted in another patient's file. This issue may cause confusion and possible incorrect assessment. No adverse event has been reported related to this issue. The figure below illustrates where the incorrect name may be displayed.

Ensure that the Thoracic VCAR software is properly exited using the exit application key prior to loading a new patient.
