\*\*\*\* IMPORTANT FIELD CORRECTIVE ACTION \*\*\*\*

Re: Volcano s5/s5i™ Family Software Version 3.2.1 / 3.2.2

## TWO POTENTIAL SOFTWARE ERRORS

### AFFECTING DIGITAL AND ROTATIONAL IVUS CATHETERS:

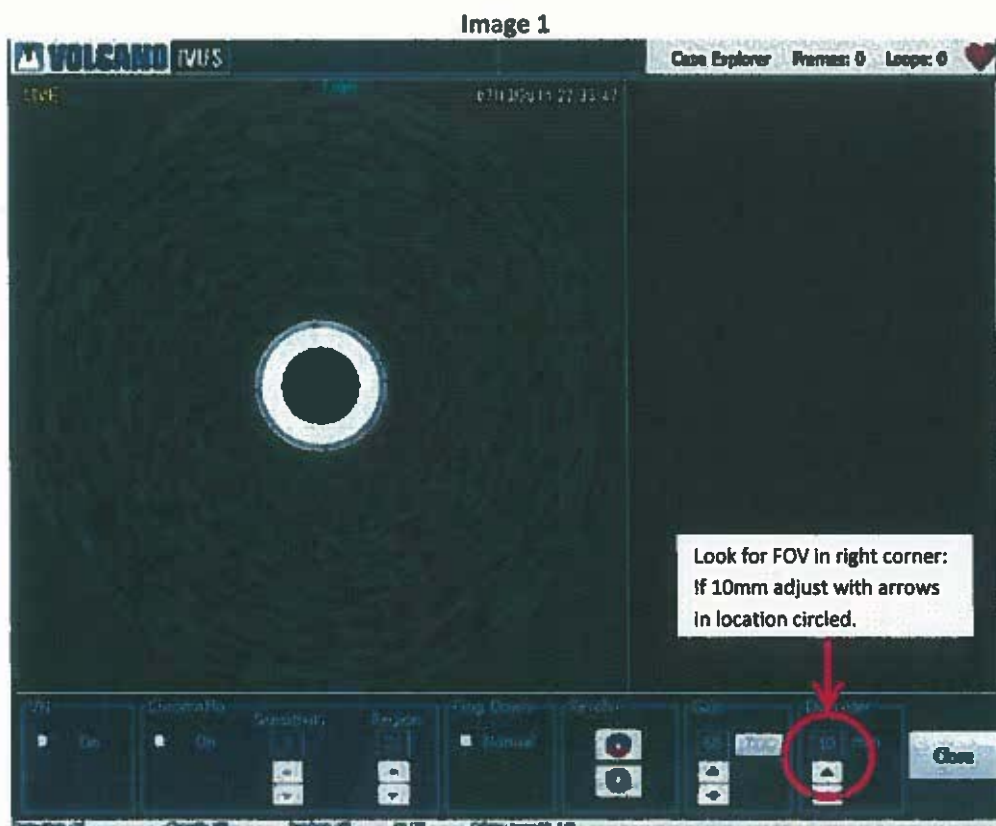
- Verify the FOV setting on the Adjust Image screen. (Refer to Image 1).
- If the system indicates 10mm, simply adjust using the up arrow or the down arrow to the desired FOV before recording.
- Confirm your measurements with those images acquired by angiography as directed by the Instructions for Use.

If you do not change the FOV from the normal (default) 10mm diameter, the error cannot occur. If possible, you should only use normal (default) FOV until the software patch is deployed.

If you must change the FOV, follow these steps:

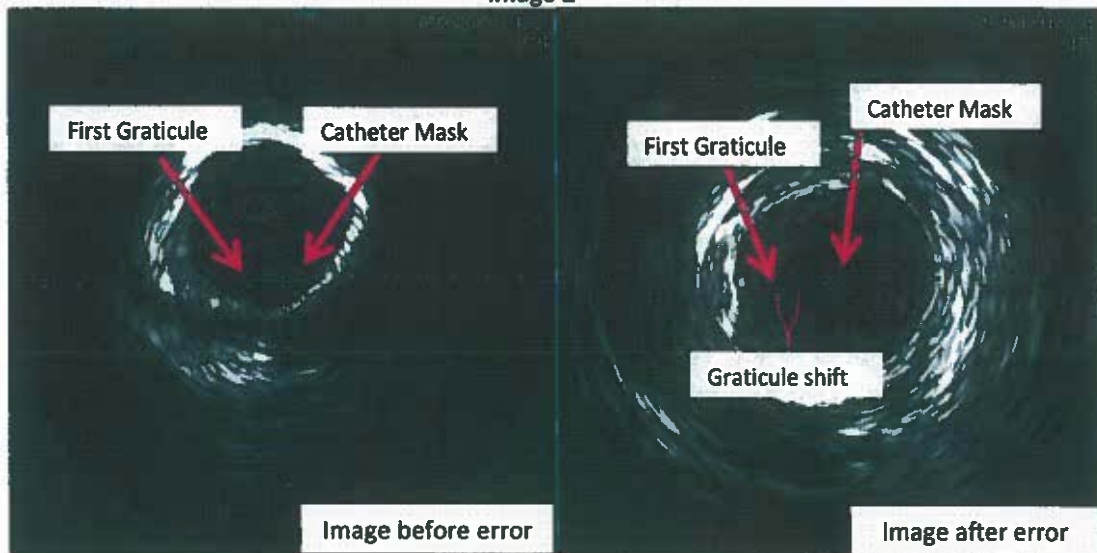
Pay attention to the following indicators as this error is easily detected by the following visual cues. Please refer to Image 2 which shows how easily the issue can be detected.

- The graticules shift from the defined FOV back to the normal (default) FOV.
- The first graticules from the center are not aligned with the edge of the catheter mask.

Once the errors have occurred any images captured in a Video Loop or Still Frame cannot be corrected. Affected Video Loops or Still frames can be detected by verifying whether the first graticules are aligned with the edge of the catheter mask (Refer to Image 2).

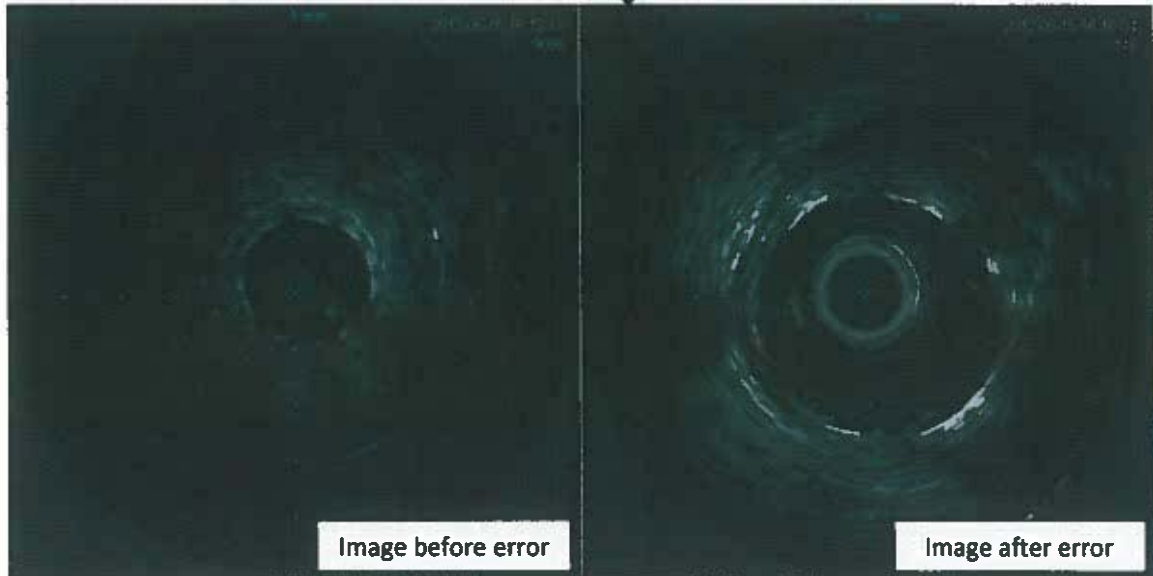
**Image 3**

Pay attention to the following indicators as this error is easily detected by one or all of the following visual cues. Please refer to Image 3 which shows how the error can be detected.

- The quality of the image is significantly brighter from previous recordings and you will not be able to modify this image by adjusting the gain.
- The Catheter mask (center of the tomographic display) will increase in size by 1.5x and will have an unnatural appearance (i.e. no blood speckle).
- The image has a zoomed in appearance and becomes more obvious as the FOV increases beyond 10mm.
- The PIMr reset will cause the LED lights to turn off and on providing the users who work with the PIMr a visual cue that the PIMr is resetting.

The images below were taken at the same point in the vessel; the correct image identified as "Image before error" is displayed on the left and the incorrect image identified as "Image after the error" is displayed on the right.

Once the errors have occurred any images captured in a Video Loop or Still Frame cannot be corrected. Affected Video Loops or Still frames can be detected by verifying whether the presence of a white ring as shown in the right hand picture of Image 3.

If you must change the FOV and you believe an error has occurred (see section below for detection of the error) then disconnect the PIMr, reconnect it and re-image. Per normal practice, confirm your measurements with those images acquired by angiography as directed by the Instructions for Use.
