FSN 72800620

**URGENT - Field Safety Notice
Medical Device Correction**

**Ingenuity CT, Ingenuity Core, Ingenuity Core¹²⁸
With Continuous Computed Tomography
(CCT) Option and have been Upgraded from
Software Version 3.x to Version 4.0.0 / 4.0.1**

Protocol Conversion Resulting in Delayed Images when using CCT Option

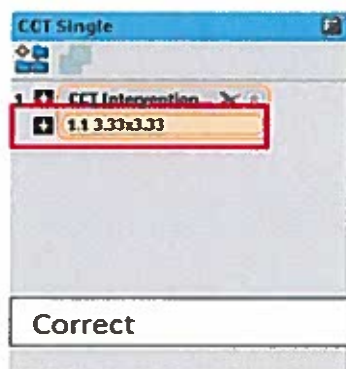
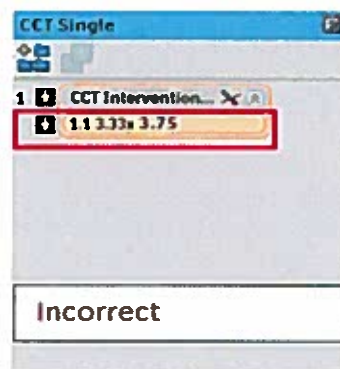
5. Double-click to open the **CCT Exam Card**.
6. Exam cards having the issue will have slice thickness and increment that do not match when opening the exam card. Please see example below:

- If the exam card has a mismatch, it is recommended to rebuild the CCT exam cards from the reference CCT exam cards.

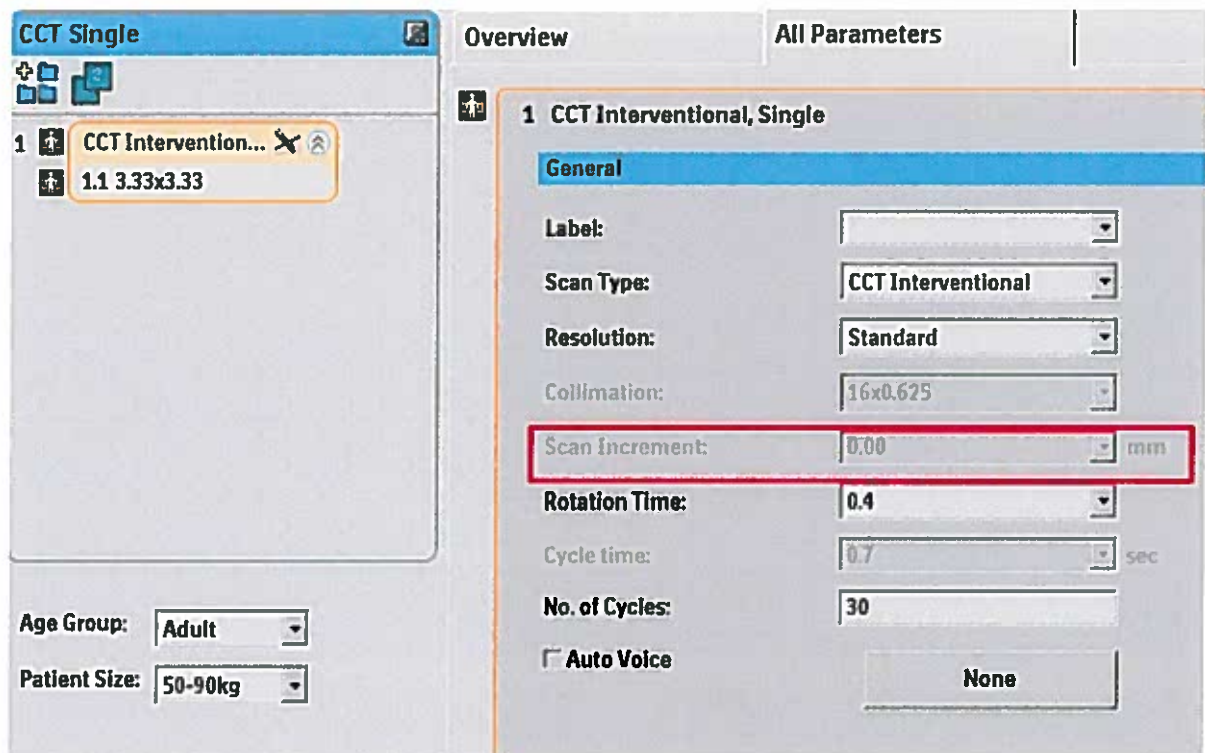
- Also note that when the acquisition step in the exam card is selected, the scan increment should be 0.00.
