FSN # 72800614, Revised

**URGENT – Field Safety Notice
Medical Device Correction**

**Brilliance CT series (6, 10, 16, 16 Power, 40, 64, Big Bore, iCT, iCT SP),
Ingenuity CT, Ingenuity Core, Ingenuity Core¹²⁸, Ingenuity Flex, and
MX8000 Dual v. EXP**

**Unintended Horizontal Patient Support / Couch Motion Correction and
Service Labeling Update Due to Unlocked Service Latch**

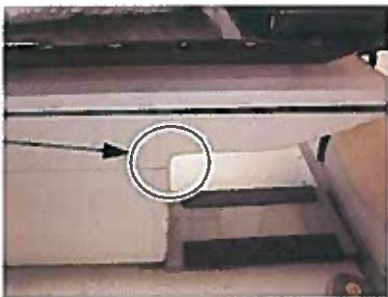
<p>Subframe Patient Support Engaged, with Covers Aligned</p> <p>Figure 1</p> </div> <div style="text-align: center;">

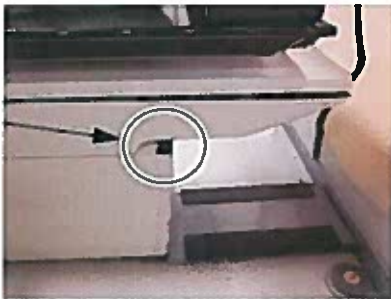
<p>PROBLEM DESCRIPTION</p>	<p>We have found, if the service latch is not properly secured during servicing of the device, the table top's subframe becomes free floating causing unintended, horizontal motion.</p> <p>To date, there have been no reported injuries or deaths resulting from this issue.</p> <p style="text-align: center;">Subframe Patient Support Cover Alignment: Engaged Versus Disengaged</p> <div style="display: flex; justify-content: space-around;"> <div style="text-align: center;">

<p>Subframe Patient Support Disengaged, with Covers Misaligned</p> <p>Figure 2</p> </div> </div>
<p>HAZARD INVOLVED</p>	<p>There is a risk of serious injury to the patient and Operator/Technician as a result of the patient support / couch subframe free floating.</p> <p>For the patient:</p> <ul style="list-style-type: none"> • There is a potential for disconnection or movement of invasive medical devices such as I.V.'s, tracheostomies, and surgical drains <p>For the Operator/Technician:</p> <ul style="list-style-type: none"> • There is a potential pinch point on the subframe; and • A potential for entrapment between the table and the gantry if the Operator/Technician stands between them to shift the patient forward

- a. If the subframe moves, it is not locked in place. Discontinue clinical use and contact your service provider immediately.
 - b. If the subframe does not move, visually verify that there is no misalignment as shown in the photo in Figure 2 in the Problem Description and the lower diagram below.

- If there is misalignment (identified by 'Gap' in the figure), discontinue clinical use and contact your service provider immediately.
 - If there is no misalignment, the system is clear for clinical use.
