Philips Healthcare

FSN 88200484

URGENT – Medical Device Correction
Manual Collimator Exchange system in use with an
ADAC VERTEX Plus, CARDIO, SOLUS or VERTEX V60 imaging system

Collimator cassette may not engage, resulting in potential injury

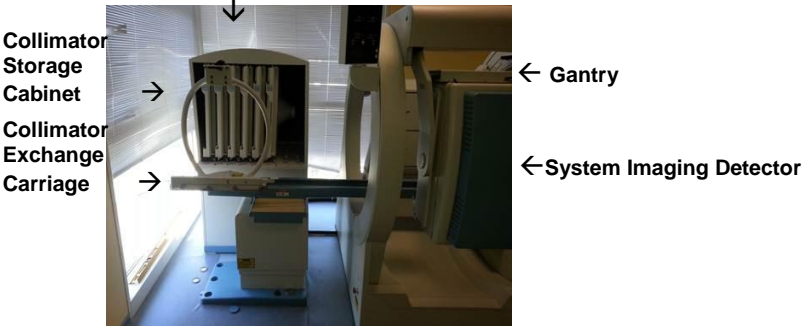
</div> <p style="text-align: center;">Figure 1: Manual Collimator Exchange system</p>

PROBLEM DESCRIPTION	<p>Philips Healthcare received a report from the field that during a manual collimator exchange procedure, the operator was attempting to slide the collimator cassette containing the detector 2 VERTEX High Resolution (VXHR) collimator from the Collimator Storage Cabinet onto the Collimator Exchange Carriage.</p> <p>As the VXHR Collimator and collimator cassette was being slid onto the carriage, the cassette did not align with the carriage top guide rollers and mechanical lock. The collimator and collimator cassette fell off of the carriage and onto the floor. This resulted in the operator receiving a minor injury. There have been no reports of serious injury as a result of this situation. The Manual Collimator Exchange system and Storage Cabinet are pictured below. Refer to Figure 1.</p> <p style="text-align: center;">Stored Collimators and Collimator Cassettes (Arrow indicates the collimator cassette storing the VXHR collimator)</p> <div style="text-align: center;">

HAZARD INVOLVED	<p>During a manual collimator exchange procedure a fall of the collimator and/or collimator cassette from the Collimator Exchange Carriage may result in serious injury to a person if it comes in direct contact with the operator and/or the service personnel.</p>

<p>Figure 2: System Label</p>
ACTION TO BE TAKEN BY CUSTOMER / USER	<ul style="list-style-type: none"> • If a misalignment on the top and/or bottom of the guide rail between the cabinet and carriage can be visually detected do not continue with the collimator exchange procedure. • If the misalignment is visually detected, be aware that the customer/user cannot remedy this issue and will require service interaction prior to the continued use of the system. • This letter should be placed in your User Documentation until otherwise notified.
ACTIONS PLANNED BY PHILIPS HEALTHCARE	<p>Philips Healthcare is initiating this field correction consisting of:</p> <ul style="list-style-type: none"> • The distribution of a Field Safety Notice 88200484 informing the operator of the issue, and • Conducting the appropriate field correction through a Field Change Order (88200484).
