URGENT - Field Safety Notice

Medical Device Correction

Ingenuity TF PET/CT running software version 4.0.2 (4.0.0.26645) Software Issues

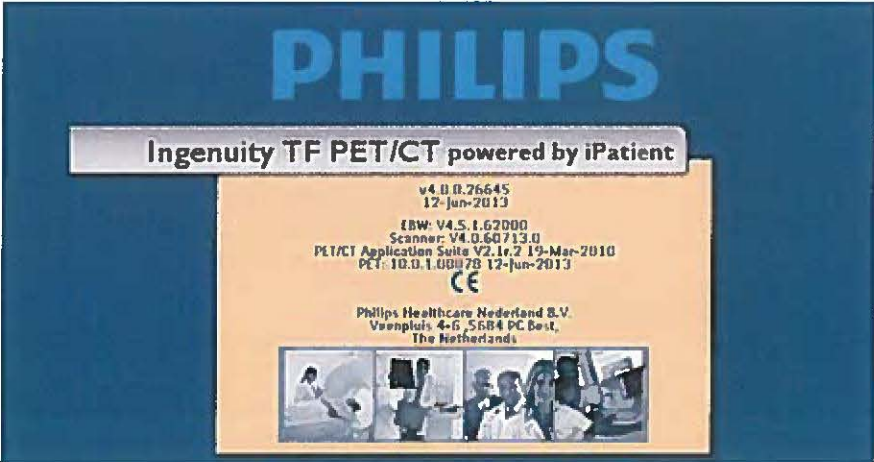
| <p>HOW TO IDENTIFY AFFECTED PRODUCTS</p> | <p>The help screen will indicate "v4.0.0.26645" as pictured below:</p> |

| <p>ACTIONS PLANNED BY PHILIPS</p> | <p>Philips will be releasing Proactive Field Change Order (FCO) 88200515 to deploy software version 4.0.3 to correct the issues described above. This update will include both hardware and software.</p> <p>Your Philips Field Service Engineer will contact you to schedule the update. The software and hardware installation will take approximately 3-4 days, followed by 3 days of onsite support from your local Philips clinical applications specialist.</p> <p>Because of the software change, your custom site-specific exam cards will not be available on the system after the upgrade. The CT parameters for all custom CT and PET/CT exam cards can be saved via the Print & Text Tool in the Exam Card Manager prior to the upgrade. However, the PET parameters (including reconstruction protocol names that are linked to the custom exam cards) will not be exported and recorded. Please work with your Clinical Applications Specialist prior to the upgrade to develop a plan for recording the PET parameters for all custom site-specific PET/CT exam cards.</p> |

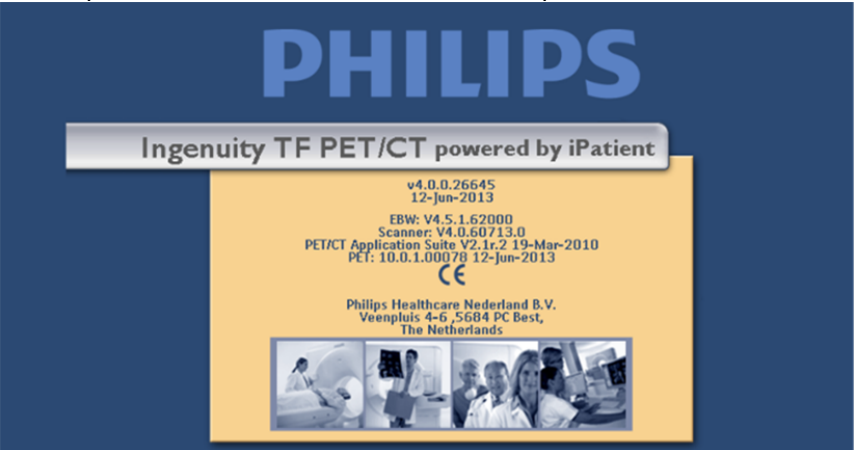
| <p>HOW TO IDENTIFY AFFECTED PRODUCTS</p> | <p>The help screen will indicate "v4.0.0.26645" as pictured below:</p> |

| ACTIONS PLANNED BY PHILIPS | Philips will be releasing Mandatory Field Change Order (FCO) 88200515 to correct this issue as described above. A Philips Field Service Engineer will contact you to schedule the update. |
