## **URGENT – Field Safety Notice**

### **Bent pedal of footswitch might cause interruption of live Fluoroscopy imaging or exposure.**

FSN for 2017-IGTBST-029

2019-February-19

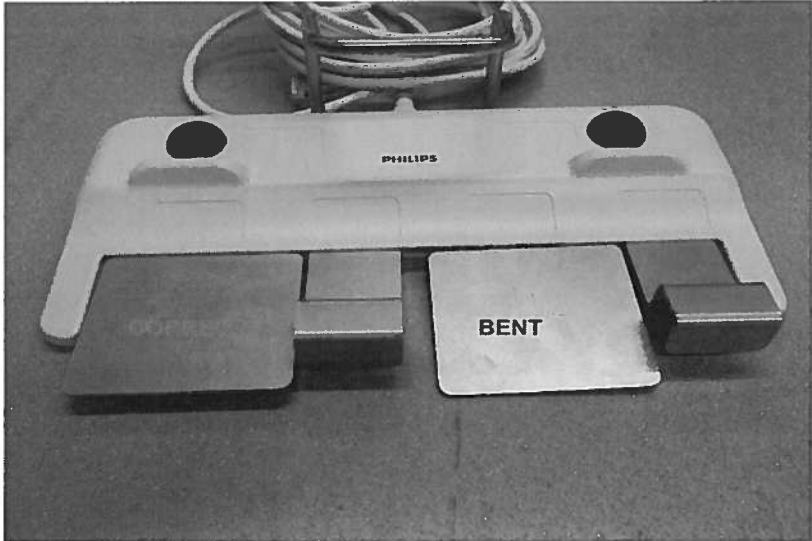
Philips noticed that due to a bent pedal of the footswitch, loss of image functionality is possible (intermittent or continuous inability of making live fluoroscopy images or exposures).

The pedal may get bent when the footswitch is frequently used on an anti-fatigue mat or on a not flat surface or in the pedestal.

<p><i>Left pedal is correct. Third pedal from left is bent. Distance to floor should be approx. 12mm (0,47inches).</i></p> <ul style="list-style-type: none"> <li>Do not use the footswitch on an anti-fatigue mat or in the pedestal.</li> <li>Please ensure that all staff with access to the affected systems are informed of the content of this Field Safety Notice.</li> <li>Include this Field Safety Notice together with the documentation of the system until the system has been corrected by Philips.</li> </ul>
<b>ACTIONS PLANNED BY PHILIPS</b>	<p>The problem will be resolved by an update of the mechanical hardware of the Footswitch that will prevent that the pedals of the footswitch becoming bent.</p> <p>This mechanical hardware is available by February 2019.</p> <p>You will be notified by your local Philips representative to schedule a date for installation of this mechanical hardware update.</p>

<b>ACTION TO BE TAKEN BY CUSTOMER / USER</b>	<ul style="list-style-type: none"> <li>Before the start of a procedure, the user must check the footswitch for possible bent pedals. See images below on how to identify a bent pedal. If bent pedals are found the procedure should not continue and Local Service should be contacted.</li> </ul>
