Safety Advisory Notice SY015/19/S

syngo.CT Cardiac Function
used in *syngo.via* VA20A, VA30A or VB10A

syngo.CT Cardiac Planning
used in *syngo.via* VB20A or VB30A

Subject: syngo.CT Cardiac Function / Planning – Risk of wrong measurement in the annulus-plane

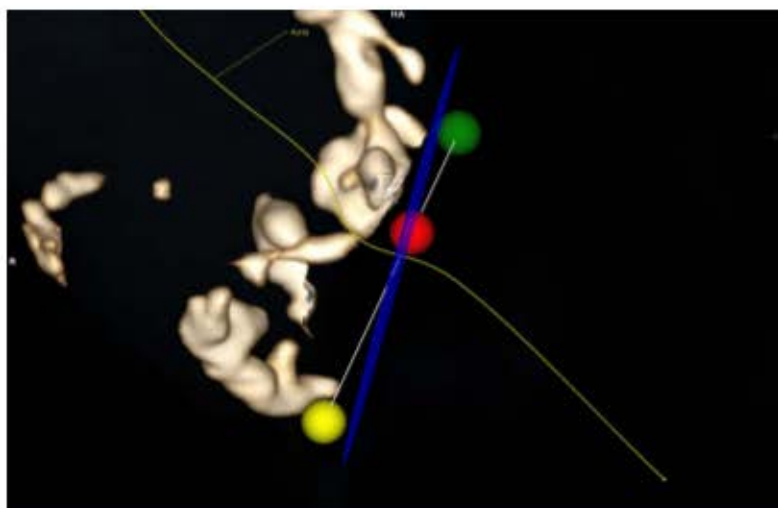
During the automatic procedure a smoothing algorithm subsequently adjusts the shape of the centerline. In unfavorable conditions this smoothing algorithm can result in a slight distortion of the centerline and ultimately in a tilting of the measurement plane compared to the previously defined annulus plane. Any measurements of annular parameters taken under the described conditions might be incorrect due to the tilted measurement plane.

When evaluating the annular dimensions the operator has to ensure that the measurement plane is optimally aligned with the annulus plane. This can be checked in the VRT segment as shown in Fig. 1. For this check, the operator has to move to the annulus plane by pressing the button "Annulus Plane". By activating the vessel diameter measurement tool a blue measurement plane will be displayed and can be compared with the white annulus plane. If they are not aligned, as seen in Fig. 1, any measurements using the cross-sections of the curved planar reformation may not be accurate.

Fig. 1: VRT segment with angular misaligned measurement-plane (blue) and annulus-plane (white) in a worst case situation

Important: If the operator recognizes a significant deviation of two planes as shown in Fig. 1, it is absolutely essential to avoid any measurements in the CPR segments using the cross-sections at the annulus plane.

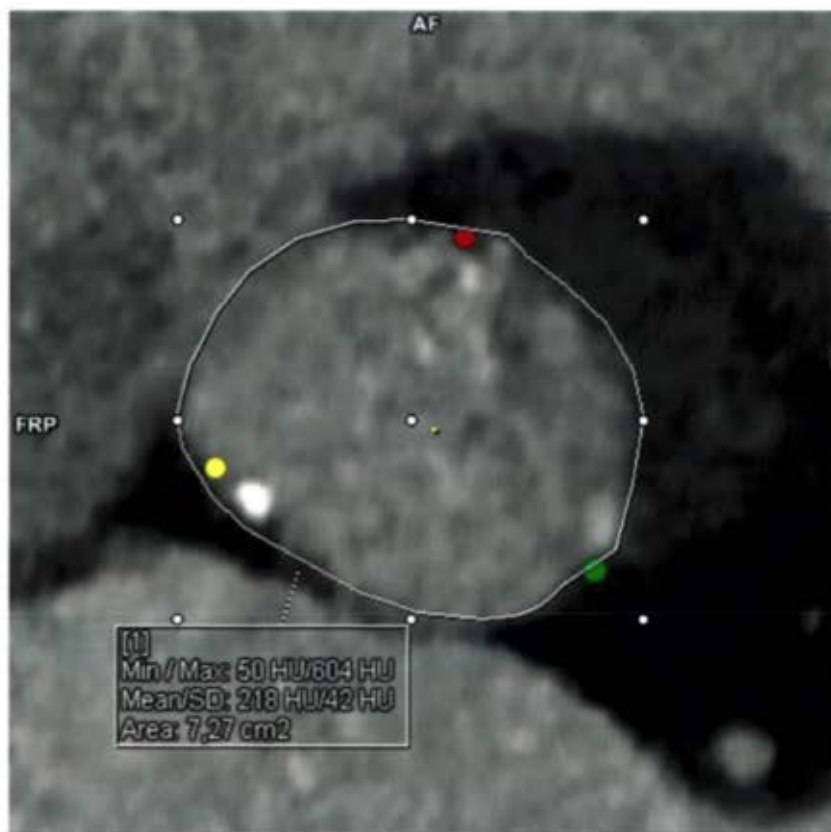
Fig. 2: MPR example for correct manual measurement using the function "ROI Polygonal Measurement"

Workaround: As shown in Fig. 2 any annular measurement shall be performed manually in the MPR segment showing the annulus plane instead. The ROI Polygonal and/or Distance Line tools can be used.
