Urgent Field Safety Notice O-arm™ 1000 Imaging System

May 2019

Medtronic reference: FA870

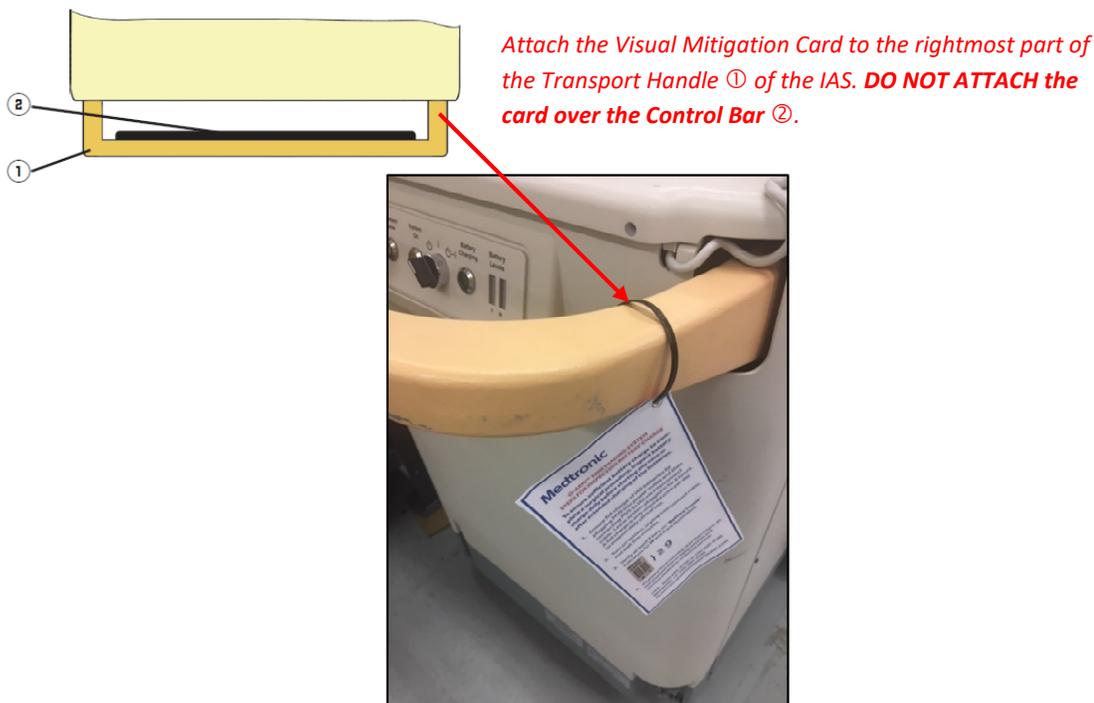
- 1) Attach the Visual Mitigation Card to the IAS of your O-arm™ 1000 Imaging System, as illustrated in the image below, and follow the directions as noted.

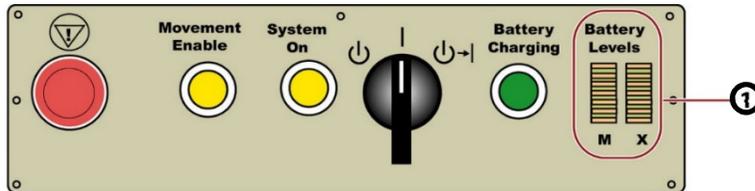
FIGURE 1

Battery Level Indicators: On the IAS Power Control Panel shown in Figure 1, the two columns of yellow LED lights (①) indicate the battery levels for the motion batteries (**M**) and the X-ray batteries (**X**). See “Battery Charge Level Indicators” in the user manual for more information about battery charge levels represented by the scrolling LEDs. See “User Performance Checks” in the user manual to ensure proper operation of the machine.

- While the Image Acquisition System (IAS) is turned on, unplug the interconnect cable and wait two minutes.
- Check the battery charge indicators on the power control panel.
- Verify that the **X** and **M** battery level indicators have at least 9 out of 10 bars illuminated to ensure sufficient battery charge to accomplish the procedure.
- If battery level indicates less than 9 bars, do not proceed with imaging session and contact Medtronic technical service +1-720-890-3160; or via email to RS.NAVTECHSUPPORT@MEDTRONIC.COM.

- While the Image Acquisition System (IAS) is turned on, unplug the interconnect cable and wait two minutes.
- Check the battery charge indicators on the power control panel.
- Verify that the **X** and **M** battery level indicators have at least 9 out of 10 bars illuminated to ensure that the battery chargers and batteries are recharging properly.
- If battery level indicates less than 9 bars, do not proceed with imaging session and contact Medtronic technical service +1-720-890-3160; or via email to RS.NAVTECHSUPPORT@MEDTRONIC.COM.
