SOMATOM Force
SOMATOM Definition AS
SOMATOM Definition Edge
SOMATOM Definition Flash
SOMATOM Drive
SOMATOM Confidence
SOMATOM Edge Plus
with software *syngo* CT VB10A

Customer Safety Advisory Notice CT035/19/S

Subject: Potential safety related software issues in *syngo* CT VB10A software running on several types of SOMATOM CT scanners – Potential safety related issues solved in *syngo* CT VB20 software

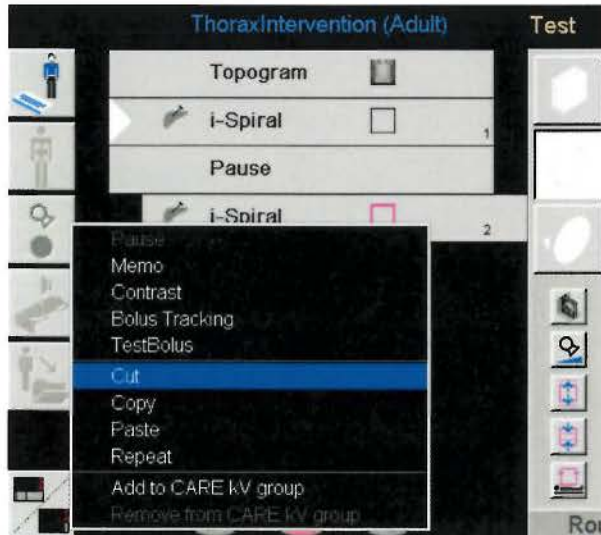
- 4.) The systems may sporadically crash during an interventional workflow using the cut functionality. Details: This issue can happen when the following conditions are fulfilled. An Intervention examination is already started and an i-mode (i-spiral, i-sequence, i-fluoro) is loaded. In this situation the chronicle context menu option <Cut> will lead to a software crash. For details see Fig. 1 below.

Fig. 1: Example of how issue 4 may occur.

- 3.) The series description changes unexpectedly: To avoid this highly sporadic issue, the operator should check the series description for any unexpected changes after the scans have been completed and before the recon jobs are started. It can be changed back manually if the recon has not yet started.
- 4.) Crash during interventional workflow: After the software crash, a system restart is needed. To prevent this happening, the loaded Intervention examination has to be canceled (press <Cancel> button) before a chronicle entry is cut.

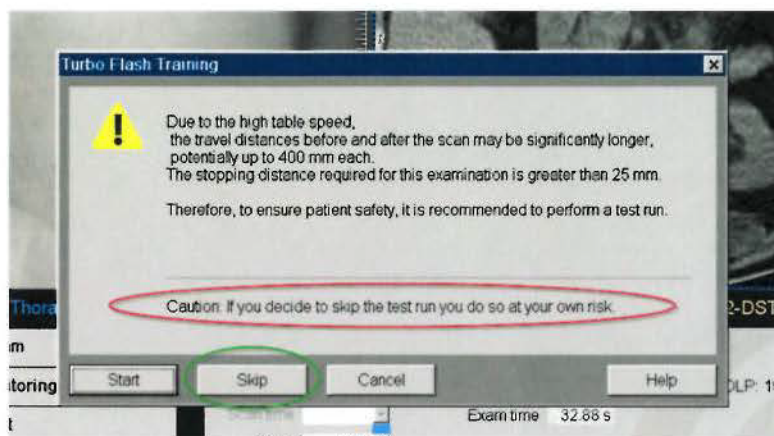
- 2.) For SOMATOM Force users only: When planning a "Turbo Flash" spiral scan, the examination task card may lock up. This can occur if a "Care Contrast" scan contains a pre-monitoring scan, a contrast sequence monitoring scan and a "Turbo Flash" spiral scan with a high pitch (>2.3).
Details: After the pre-monitoring scan, the operator selects a ROI and clicks <Accept>. Due to the high pitch (or the high table speed) of the "Turbo Flash" spiral scan, a table test move is proposed to the operator. After clicking <Start>, the system issues a request to press the <Move> button. When the <Move> button is pressed, nothing happens but the table test move dialog pops up again. The exam task card then locks up, if the <Start> button is pressed a second time.

Fig. 2: Table test dialogue with warning if skipped

- 2.) The examination task card may lock up during a "Turbo Flash" spiral scan. In order to avoid such a lock-up, two solutions exist:
 - a. The pitch can be reduced so that the table test move becomes obsolete and is not proposed to the operator any more. This consequently means the examination is no longer a real "Turbo Flash" spiral scan.

- b. The table test move is not a must and can be skipped. If this workaround is chosen, the operator must be particularly cautious and make sure that there are no obstacles in the way of the table top movement. The high table top speed during such examinations makes it impossible to stop the movement within the usually required 25 mm. The travel distance before and after the scan may be up to 400 mm. The corresponding dialog is shown in Fig. 2 below.
